SAFETY ALERT

Forestry Harvesting Operations

Wheels lock up on icy road, crew truck slides to a “soft landing” in snow-filled ditch

Location: Kenney Dam Road – Vanderhoof, BC

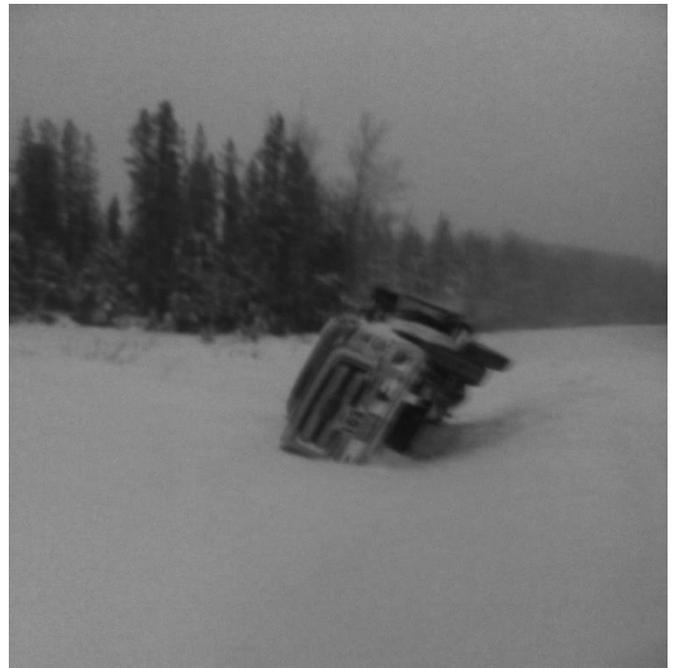
The driver applied the brakes (approximate vehicle speed of 40 km/h) but the wheels locked up on the ice and the vehicle gradually entered the right hand ditch, coming to rest at a 45 degree angle.

Previous freezing rain and snow accumulation of 30cm made for unusually poor road conditions.

The large amount of snow in the ditch softened the impact for both the vehicle and the passengers. No vehicle damage or personal injury occurred.

- Before a crew vehicle leaves a worksite ensure all snow / ice is removed from the windshield and all other glass, mirrors and external marker lights
- Snow must be fully removed from the hood, grill, front bumper and especially the roof, as it may quickly slide onto the windshield, obstructing the driver
- Don't drive a vehicle until there is sufficient cab heat to fully defrost the windshield. Keep on full defrost mode until it is safe to switch to a mix of floor / defrost
- Ensure there are no large objects on the dash that may obstruct heat flow.
