## Windfall slides off rock bluff, crushing faller

Number: 2005137160100

Core activity: Manual tree falling and bucking

Date of incident: April 2005

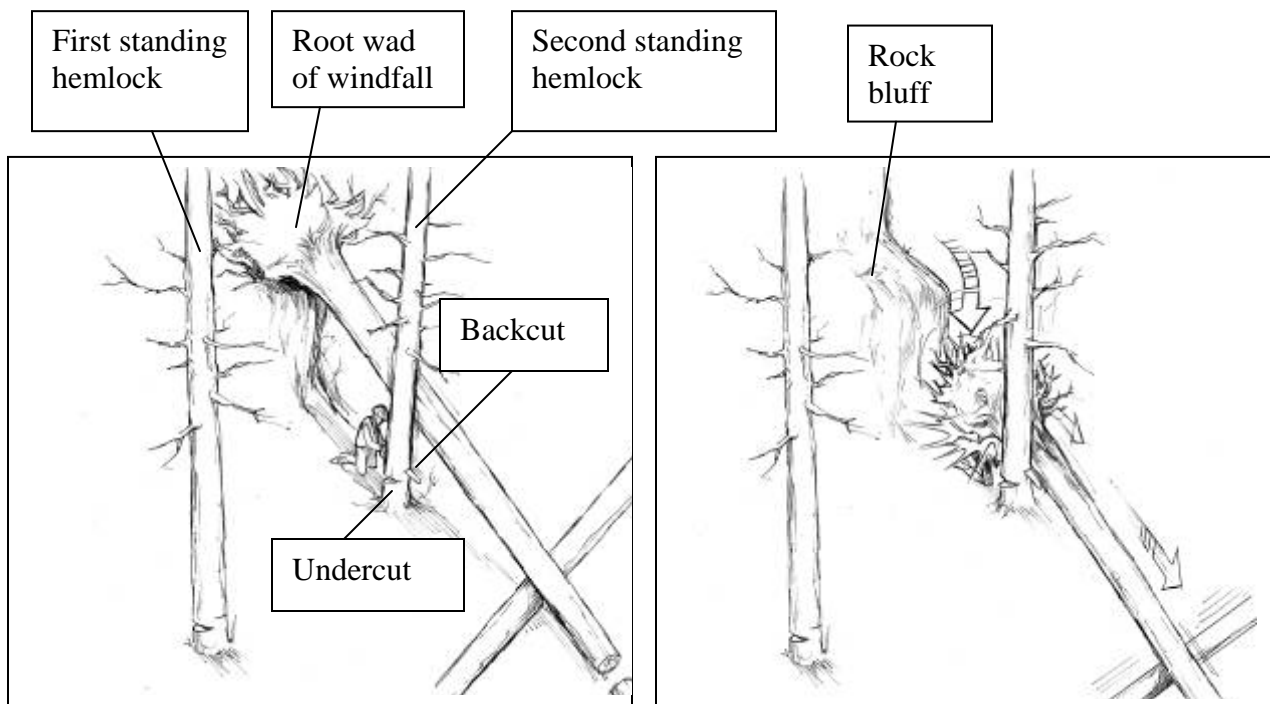
The faller placed himself in a position that was somewhat under the trunk of the wind-fallen tree and between the root wad and the standing tree (see Drawing 1, left). He had his back to the root wad. He placed his undercut and began his backcut in the second tree. The wind-fallen tree slid downhill off the rock bluff and into the faller, pinning him against the second standing tree (see Drawing 1, right).

Drawing 1: Left, showing the faller's position before the incident. Right, showing the root wad slipping off the rock bluff.

The faller's backcut was then started in the second tree at a height of 1.5 feet above ground. The position of the windfall forced the faller to crouch down and somewhat under the windfall to make his backcut. This resulted in him having his back to the rock bluff and root wad of the windfall. As he was making this cut, the windfall slid forward off the rock bluff and crushed the faller between the tree and the windfall's root wad.

The rub marks on the hemlock tree that the faller was falling and the rub marks on the windfall indicate that they were in contact with each other. This contact was the only support that was preventing the windfall from dropping forward off the rock bluff. When the faller started his backcut, the tree released slightly and the windfall was free to move forward down the hill.

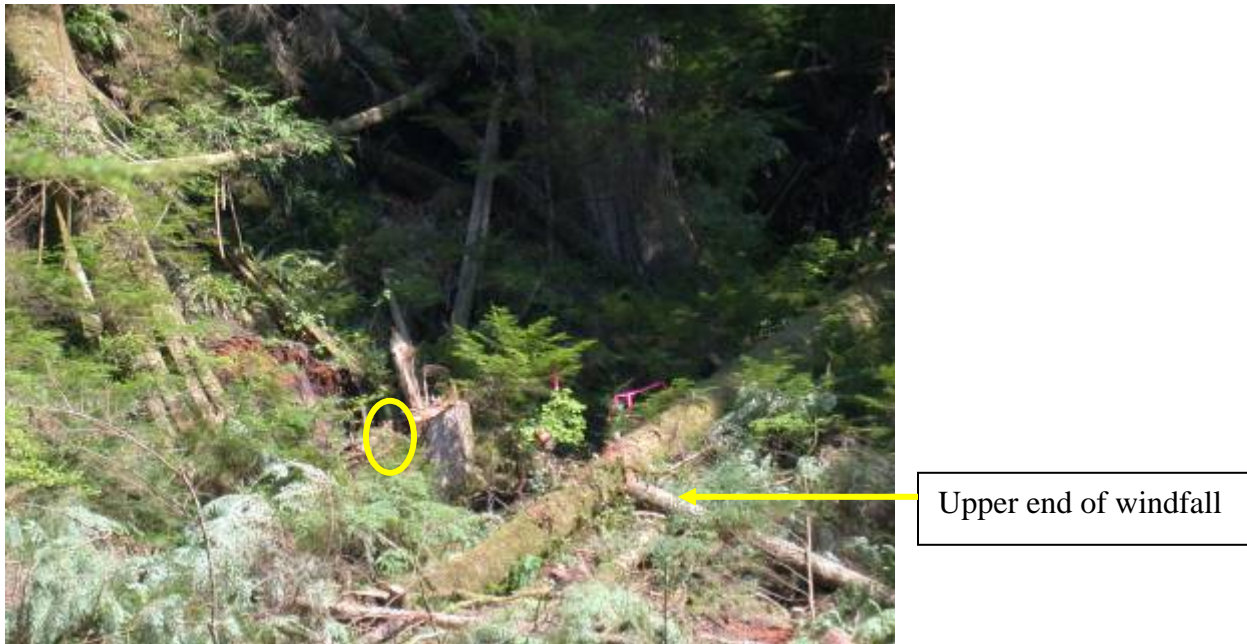
The first aid attendant arrived but no pulse could be found. The windfall was cut and the root wad slung away by helicopter to allow access to the faller. The photo shows the scene after the incident.

The faller's position at the time of the incident is shown by the oval.
