SAFETY ALERT

DESCRIPTION OF EVENT: Headrig Bandsaw Shot Through Filing Room Trap Doors

BC Forest Safety

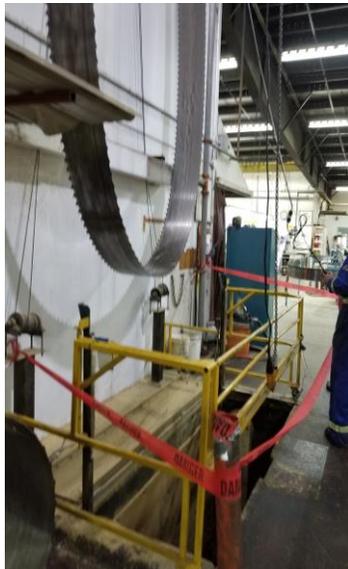
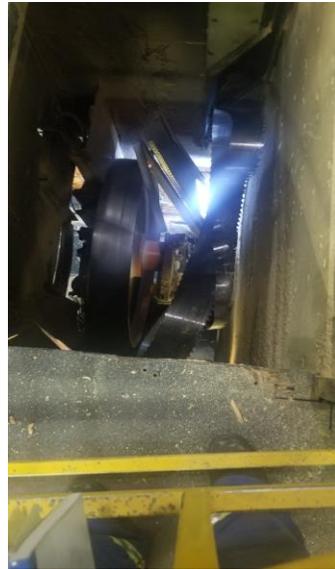
A log with a knot at the end was being sawn in half at the Headrig. As the second half of the log was being dropped onto the rollers below after being sawn in half, the knot in the log got caught on the Headrig carriage. The carriage started to slide back and dragged the log with it. The log hit the back of the Headrig bandsaw and knocked the saw off the wheels.

The tension in the saw caused the saw to shoot up through the saw-change enclosure and blow half of the filing room trap doors off its hinges. The trap door hit the removable guardrails around the enclosure. A worker operating the Headrig saw-change hoist, in front of the guardrails avoided injury due to the guardrails blocking the impact of the trap door.

Designate the area around the saw-change trap doors as a hazard zone with limited worker occupancy.

- Evaluate whether trap doors above all saw-change enclosures are substantial enough to withstand impact from potential projectile hazards below.
- Explore controls, such as installing sensors at the Headrig to detect upset conditions and shut down the equipment immediately.
