DESCRIPTION OF EVENT

Other Struck By Falling Shaft

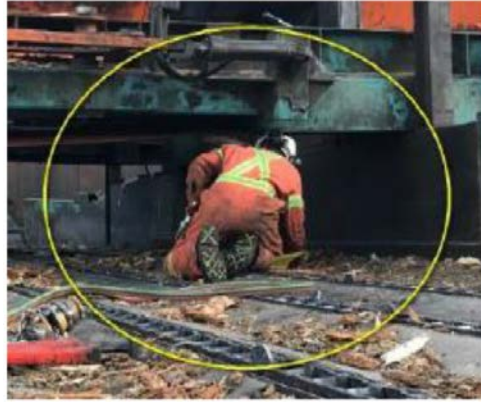
Two employees were removing an idler shaft from the bottom of a conveyor to replace bearings. The first employee was using a short length of 2X4 braced on their left shoulder to hold the shaft in place as the bolts were removed by the second employee. As the last bolt was being removed the shaft slid down the 2X4, turning slightly, striking the first employee on the face. The incident resulted in a 1cm long laceration on the second employee's upper left side lip that required 4 small stitches.

- Perform a hazard and risk assessment when working in an awkward position. Focus on line of fire hazards.
- Use proper rigging to hold up pieces of the equipment when removing bolts and gravity is an energy source.
- Develop a standard work procedure for lifting or positioning overhead components during installation or removal that includes the use of hoist or jacking devices to reduce or eliminate the need for components to be manipulated by hand.
- Senior tradespersons who work with apprentices have a responsibility to model effective hazard assessment and planning for how they will safely go about preparing for and completing tasks.

When working in overhead or awkward positions perform pre-job hazard assessments that focus on line of fire hazards.
