# MANUFACTURING SAFETY ALERT

## DESCRIPTION OF EVENT

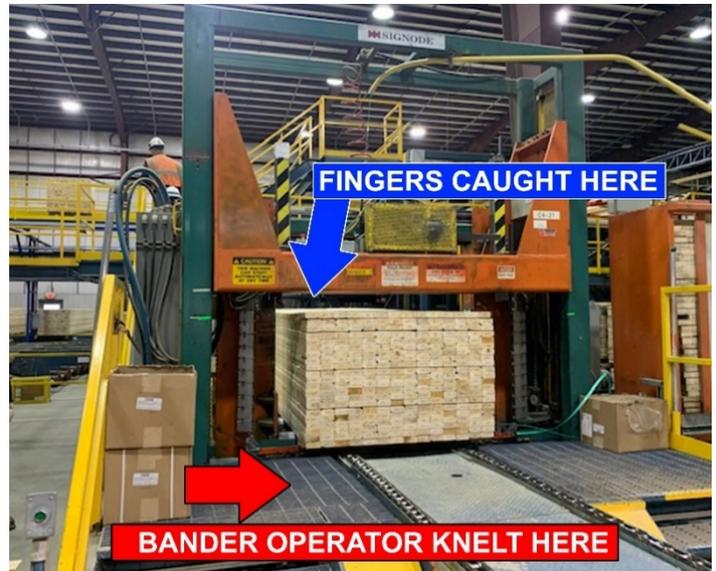
The middle dunnage was missed in a load during the automatic cycle. Operator backed up the package into the strapper to replace the missed dunnage.

The strapper operator bent down and was manually positioning the dunnage (middle bunk) with his left hand. For his stability, his right hand was on top of the package.

Once the dunnage was placed in the track it blocked the photocell which triggered the strapper auto cycle. The plate dropped and pinched the workers fingers.

- Worker entered “the bite” and did not lock out.
- Worker inserted dunnage with his hand instead of using the manual or automatic feeder.
- 12' middle bunk/strap did not register in bander program due to sequencing issues.
- Operator did not foresee the risk or assess the risk with a FLHA.

- Investigate stacker to bander sequencing program and identify opportunities to rectify situations where package information is lost.
- Install remote disconnects with test start buttons near the bander machine.
- Review JSA/SWP to identify improvements in processes related to fixing upset conditions at the bander.

Consider installing a remote disconnect with test start buttons near the bander machine.
