MANUFACTURING SAFETY ALERT

DESCRIPTION OF EVENT

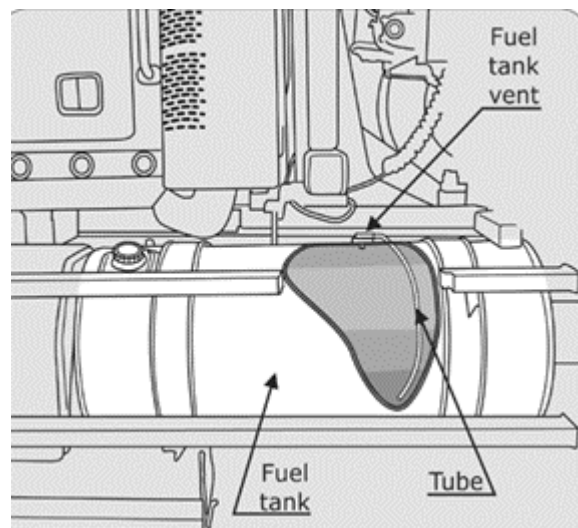
A log transport truck quit running while driving up a steep hill on a main highway. The driver got out to investigate the cause. While he was investigating, a flash fire occurred after he removed the diesel tank fuel cap. The driver was seriously burned.

After the incident, investigators found that the end of the fuel tank vent tube was blocked with mud. This blockage caused a pressure differential in the fuel system that starved the truck of fuel and caused it to shut down. When the driver opened the diesel tank fuel cap to investigate, he was exposed to hot diesel vapors that ignited due to several potential ignition sources, including static electricity, contact with hot exhaust surfaces and contact with energized electrical equipment.

1. Develop and implement written safe work procedures for maintaining fuel tank vent systems and for refueling and educate and train drivers in those procedures.
2. Check your vehicle's fuel tank vent system as part of your daily pre-trip inspection. Make sure, the end of the tube is not clogged with mud or other debris. Clean it if needed.
3. Bond and ground equipment when refueling.
