MANUFACTURING SAFETY ALERT

DESCRIPTION OF EVENT

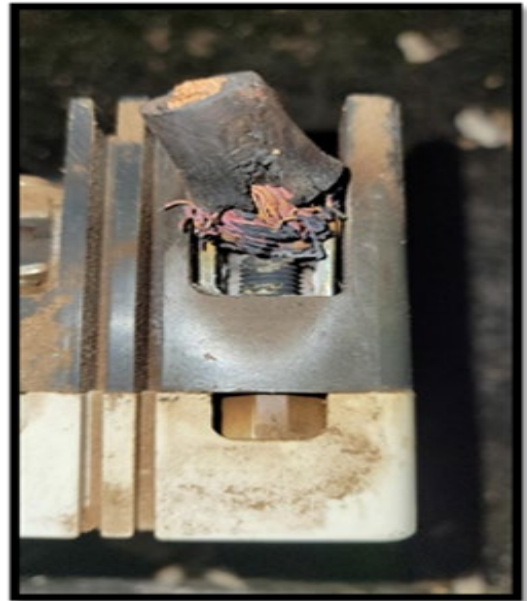
An electrician was called to troubleshoot a melted plastic odour at the Twin Bandmill MCC. He checked the bucket for loose or damaged connections and could not locate the cause of the odour.

The odour was noticed occasionally throughout the remainder of the shift. When the electrical supervisor arrived the next morning, he conducted a thermal scan and found there was a melted connection on the line side of the C phase East Bandmill breaker.

To reduce fire risk, schedule preventive maintenance for electricians to clean MCC cabinets.

1. Schedule preventive maintenance to conduct regular thermal scans of MCCs.
2. Ensure thermal scans are part of troubleshooting when melting plastic odour is detected.

When a melted plastic odour is noticed in or around a MCC unit give the electricians time to troubleshoot the problem or consider shutting down the equipment until additional help arrives.
