MANUFACTURING SAFETY ALERT

DESCRIPTION OF EVENT

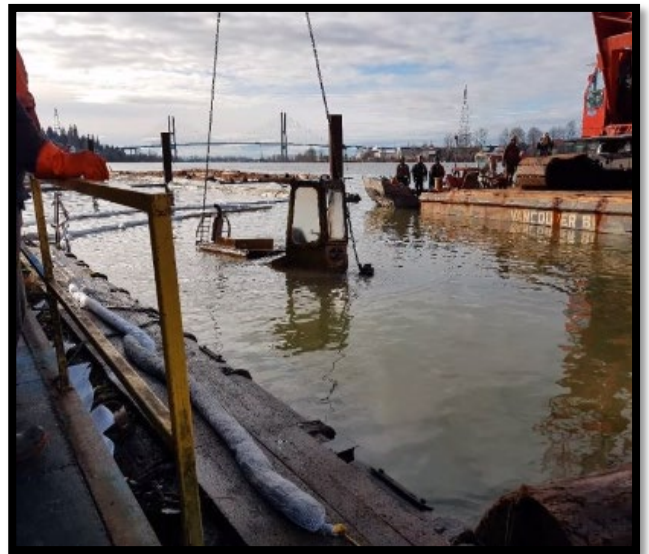
While stowing bundles, a boom boat (side winder) rapidly sank in 290' of water. The Operator was able to jump clear and was uninjured.

Possible causes: shearing of drive line mounting bolts exposed a 24" hole in the hull, or, hull was compromised, and a hole was created by impacting a log end. Side winder stayed submerged after resting on bottom at low tide. With flood tide the boat did not re-float.

1. Do pre-trip inspections and confirm no (minimal) water in the hull.
2. Complete regular maintenance on the hull to prevent rust weak spots.
3. When boats out of the water, conduct thorough inspections.
4. Watch for protruding logs from bundles, especially small diameter logs.
5. Install high-water alarm in the hull.

Ensure pre-trip inspections accurately identify hull weak spots or excessive water in the hull.
