MANUFACTURING SAFETY ALERT

Pinched Finger Under Planer Plate

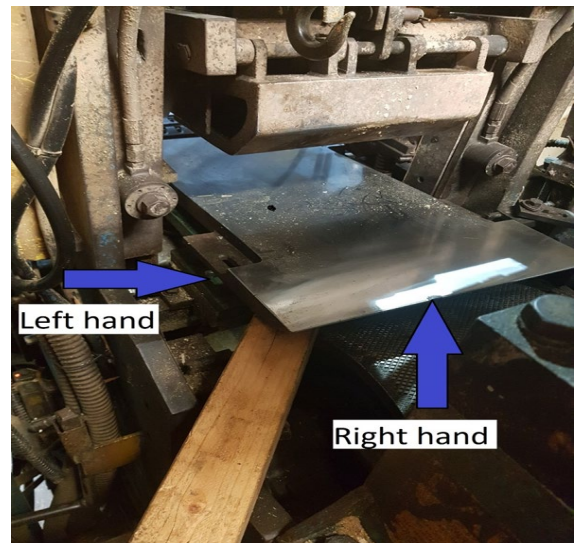
A contractor and an employee were changing the bedplate on a planer. The contractor had the bedplate held up with dunnage and the employee was guiding the bedplate out when the dunnage slipped. The employee's left fingers were pinched between the metal bedplate and the flat surface.

The employee immediately pulled their hand from underneath the bedplate and reported to first aid.

1. Develop specific SWPs for infrequent high-risk tasks.
2. Ensure a planer bedplate can be removed and installed with hoists and rigging to eliminate using dunnage as an option.
3. Complete a detailed FLHRA that focuses on specific tasks for the work that needs to be completed. Multiple FLHRA's may be required to effectively manage large work scopes.

To address high-risk activities, complete a detailed FLHRA that focuses on specific tasks for the work that needs to be completed.
