MANUFACTURING SAFETY ALERT

DESCRIPTION OF EVENT

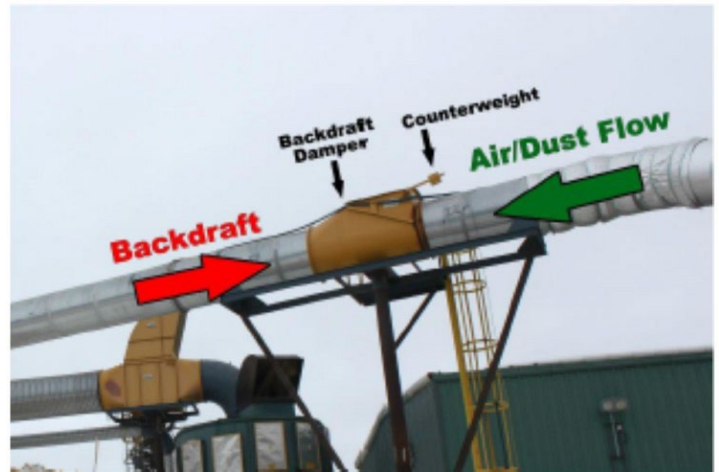
Upon investigation, it was identified that the backdraft damper on the dust extraction system failed to close when the blower was shut down.

The backdraft damper (pictured) is designed to automatically close when positive air flow has stopped.

During a closer inspection, it appeared that the backdraft damper may have been frozen in the open position. Due to the bearings being stiff, the counterweight may have been out of position.

- Update monthly preventative maintenance to include lubricating the backdraft damper swivel bearings.
- Before start-up, confirm the gate is fully operational after prolonged weekends and during cold weather.
- Investigate the feasibility of automatic sensors that alarm if the damper fails.
- Ensure the counterweight on the damper is properly calibrated to ensure correct operation.

Develop a start-up inspection of the ventilation equipment to confirm that all safety systems are operating.
