MANUFACTURING SAFETY ALERT

DESCRIPTION OF EVENT

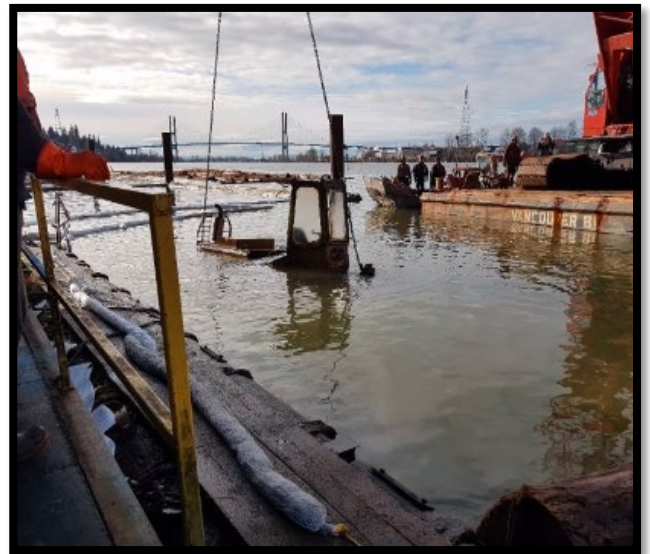
A boom boat (sidewinder) rapidly sank in 290' of water while stowing bundles. The operator was able to jump clear and was uninjured.

The sidewinder remained submerged after resting on the bottom at low tide. When the tide rose, the sunken boat did not resurface.

Possible Causes: The sheared drive line mounting bolts exposed a 24” hole in the hull or the hull was impacted by a log end that created a hole.

1. Do pre-trip inspections and confirm no (minimal) water in the hull.
2. Complete regular maintenance on the hull to prevent rust weak spots.
3. When boat is out of the water, conduct thorough inspections.
4. Watch for protruding logs from bundles, especially small diameter logs.
5. Install high-water alarm in the hull.

Conduct pre-trip inspections to accurately identify hull weak spots or excessive water in the hull.
