SAFETY ALERT – Trailer Frame Structural Failure

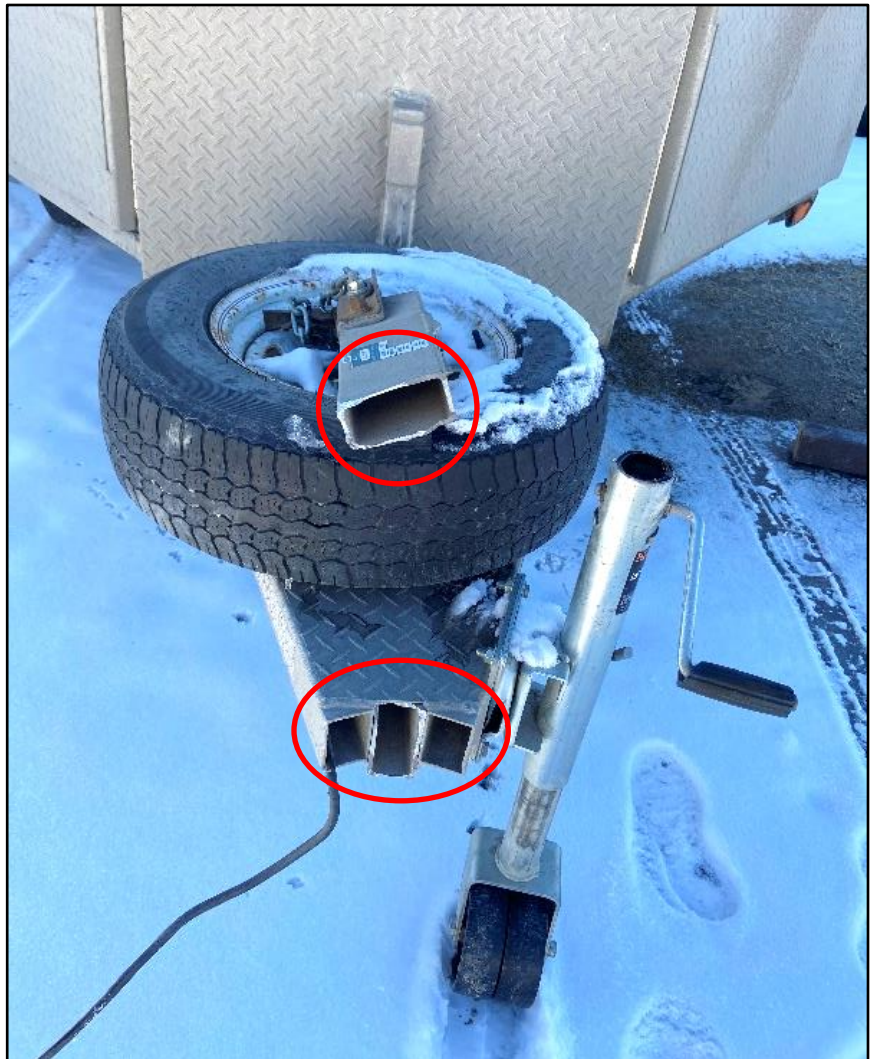
An aluminum trailer loaded with two snowmobiles was being towed on a resource road when the tongue of the trailer broke at the connection point for other beams comprising the frame.

The safety chains were affixed to the tongue and following the break, the trailer became fully detached from the towing vehicle.

Dark, corroded areas at the break indicate pre-existing cracks.

Recent inspection by a certified inspector did not identify any cracks or indications of the impending failure.

- Complete regular trailer inspections with extra attention on the trailer tongue and inspection of frame.
- Ensure thorough inspections for signs of cracking.
- Consider incorporating non-destructive testing (NDT) into scheduled inspections.
