MANUFACTURING SAFETY ALERT

Angle Grinder Incident

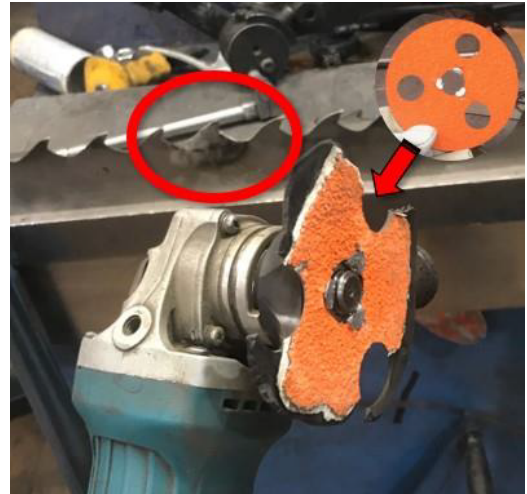
An employee was using an angle grinder with a sanding disc attachment to sharpen a welded saw tooth. While completing this task the sanding disc hooked the tooth causing the disc and backing plate to break apart, striking the employee. The employee was wearing a face shield, but it was not fully lowered, and debris flew into his face, causing a laceration.

- The sanding disc had a three-hole transparent design which has potential to catch on objects and break apart.
- There was no guard installed on the angle grinder.
- The employee did not put the face shield all the way down because it was damaged and scratched affecting visibility.

- Do not use this type of sanding disc and communicate its risk potential to other operations.
- Audit all angle grinders to ensure they have the proper guards in place and are in safe operating condition.
- Review safe operating procedures for use, care and maintenance of angle grinders with all maintenance employees.
- Ensure appropriate PPE is in good condition and used correctly.
