# MANUFACTURING SAFETY ALERT

### Sharp Edges on Guide Cart - Incident

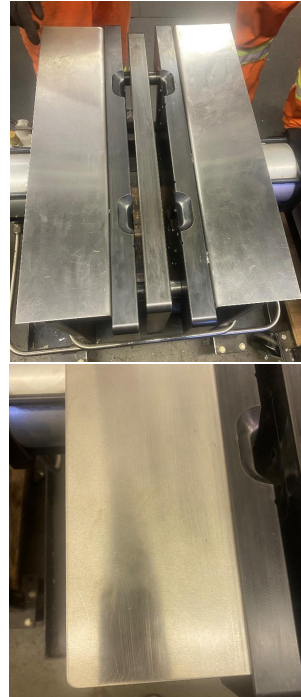
Ergonomic mats created an uneven floor surface in the Filing Room. The uneven surface caused a babbitt mold cart to tip over when the wheels got stuck as a worker was adjusting its position.

The worker tried to catch the cart when it started tipping over and the sharp corners of the rack lacerated the worker's forearms. The worker required three stitches on each arm.

The sharp edges on the cart which contacted the employee's forearms as he attempted to catch the cart as it was tipping over.

The edges after rounding off.

- Round off square edges of a cart.
- Eliminate the hazard. Ensure there is enough room and make carts more ergonomic. Fix the uneven floor surfaces.
- Complete a "sharps" assessment on metals carts.
