# MANUFACTURING SAFETY ALERT

### Press Outfeed Fire

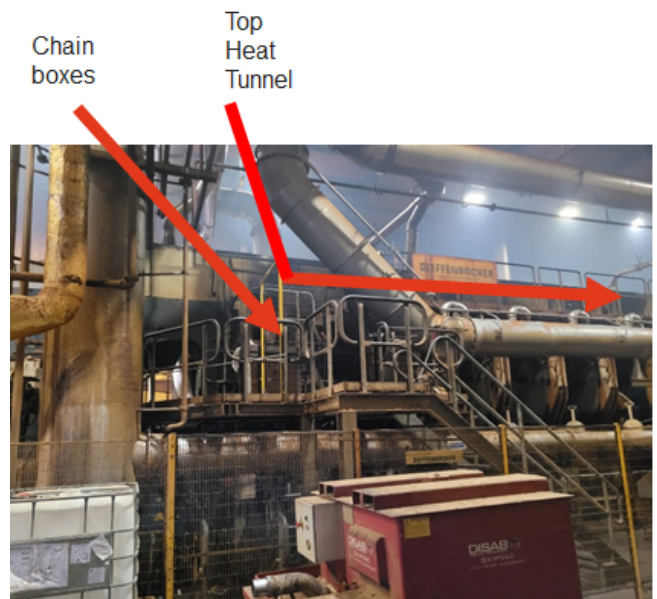
A fire occurred at a press outfeed. It was caused by a build-up of material located in the area behind the chain cleaning boxes, in the top heat tunnel.

The minimax activated at the press outfeed and the fire team responded. It took two hours to extinguish the fire due to it re-igniting as a result of the difficult location and the spread.

There was a delay in using the foam suppressant as fire team members were using an old fire hydrant. Approximately 15 minutes passed before the correct hydrant was identified and used.

- Make the area safe and start clean up.
- Replace damaged chain and rolling rods.
- Identify and communicate fire hydrant positions.
- Reminded fire teams to conduct hydrant checks and fire box checks as part of the fire team training - add these to the monthly PM schedule.
- Minimax attending site should look to add foam/deluge suppression system at the top heat tunnel.
