INDUSTRY SAFETY ALERT

Water pump exhaust ignites container of gasoline

Date of Incident: June 2024

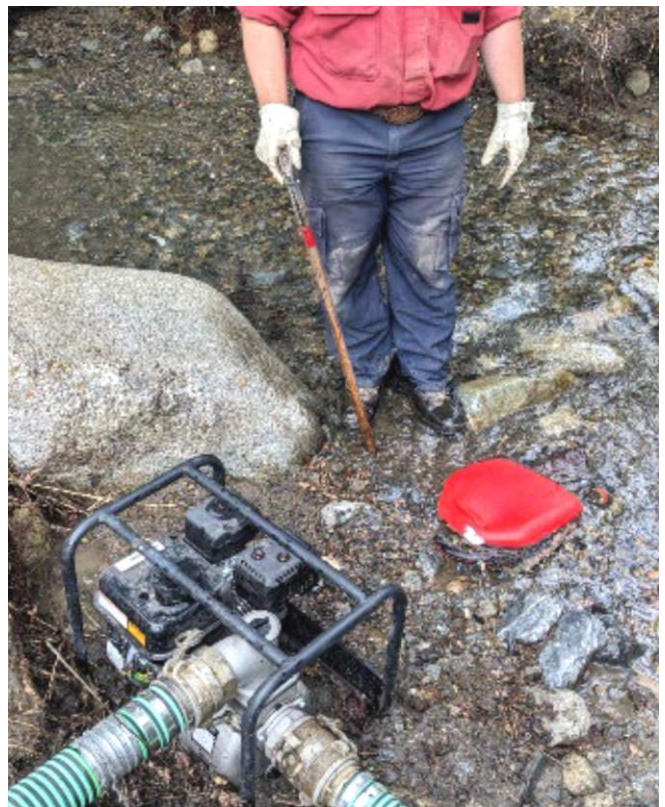
During the filling procedure, one of the tender operators moved the pump's jerry can filled with gasoline to allow him to be able to adjust the suction hose. This inadvertently placed the jerry can directly in front of the pump exhaust, causing it to explode a few minutes afterwards. This lit the suction hose on fire, spread burning fuel downstream approximately 10 metres, and ignited the opposite bank.

Above: The location and condition of the jerry can as found by the IA crew.

The immediate cause of the jerry can explosion was the gasoline vaporizing from the heat of the pump exhaust and becoming pressurized in the jerry can. Eventually the jerry can melted and the fire was likely caused by the pressurized gasoline and vapours contacting the hot pump exhaust.

The root cause was limited space at the pump site. The pump equipment was crowded at the pump site due to brush and lack of clear space, which may have caused there to be limited places to place the jerry can.

- Ensure jerry cans are not placed on the same side of the pump as its exhaust outlet, even for a few minutes.
- When choosing a pump site, allow for ample space to avoid equipment congestion. Consider the surrounding fuel types, the presence of gasoline, and a heat source (pump exhaust).
- Encourage equipment operators to report any safety concerns about pump sites. Corrective actions will vary from site to site but could include brushing out a pump site or removing tripping hazards.
- Keep fuel containers and fuel lines as far as operationally possible from water sources to prevent environmental contamination in the event of leaks or spills.
