MANUFACTURING SAFETY ALERT

Fire - Debarker Baghouse

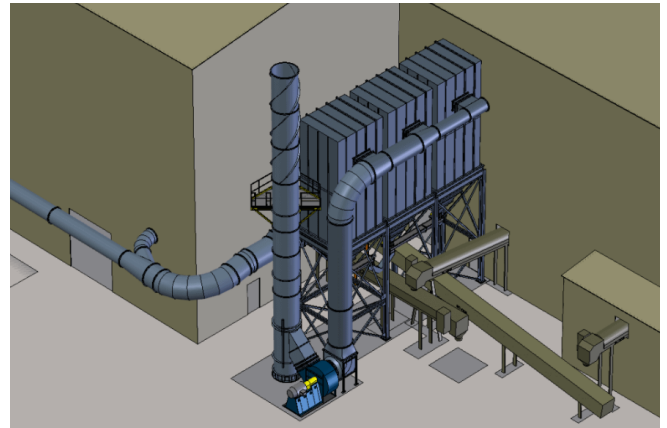
An explosion and fire occurred in the sawmill's debarker baghouse during normal operations due to a seized debarker feedroll packed with cedar bark.

This led to a friction fire that generated sparks, which entered the dust collection system.

Although the system had a spark detection mechanism, two critical failures allowed the sparks to pass through. The first sensor triggered a deluge response that did not activate, and the second sensor initiated an abort gate response that also failed. As a result, sparks reached the baghouse, causing two explosion panels to blow out and activate the internal fire suppression system.

- Implement a preventative maintenance (PM) process for debarker feedrolls after cedar runs.
- Schedule regular inspections of safety components in dust collection systems.
- Maintain spark detection systems per manufacturer's guidelines and arrange for third-party inspections.
- Include winterization planning for spark detection deluge systems to prevent freezing.
- Connect the spark detection system to the PLC for remote alerts on sparks or faults.

Establish a preventative maintenance process for debarker feedrolls, ensuring regular inspections of safety elements, proper maintenance of spark detection systems, winterization plans to prevent freezing.
