Log vandalized with railway spikes reaches sawmill

Date: March 24, 2025

Location: Columbia/Shuswap

INDUSTRY SAFETY ALERT

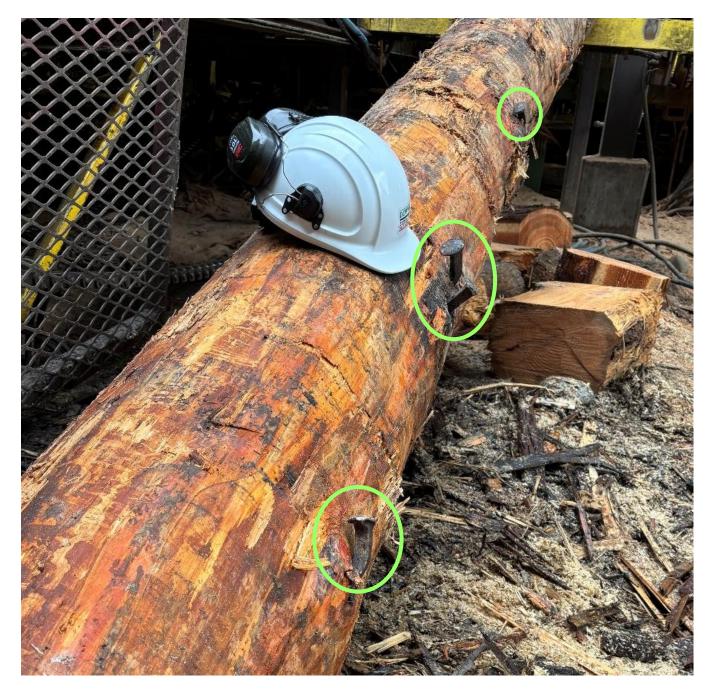
RAILWAY SPIKES IN LOG:

A debarked log was entering a sawmill when an operator noticed it was spiked. Fortunately, the operator had only sawn the non-spiked side. In total the log contained 8 railway spikes.

This log had been handled multiple times before entering the sawmill and was debarked prior to the hazard being initially identified by a sawmill worker.

Metal in logs entering a manufacturing facility has the potential to harm people and cause significant damage to equipment.

Communicate the potential hazard to all workers involved in the process from development to manufacturing so that contaminated logs can be prevented from entering a production facility.

Workers that should be aware of the potential for metal and other contaminants are field crews, harvesting and loader operators, log truck drivers, scale operators and scalers, log yard or sort yard operators and production facility primary breakdown operators.

If metal or another contaminant is discovered, the hazard must be removed immediately and its presence communicated to everyone involved in the process.
