# INDUSTRY SAFETY ALERT

## Hydrostatic-Drive Skidder Brake Failure

**Date:** June 2025

**Location:** Kootenay-Boundary TSA

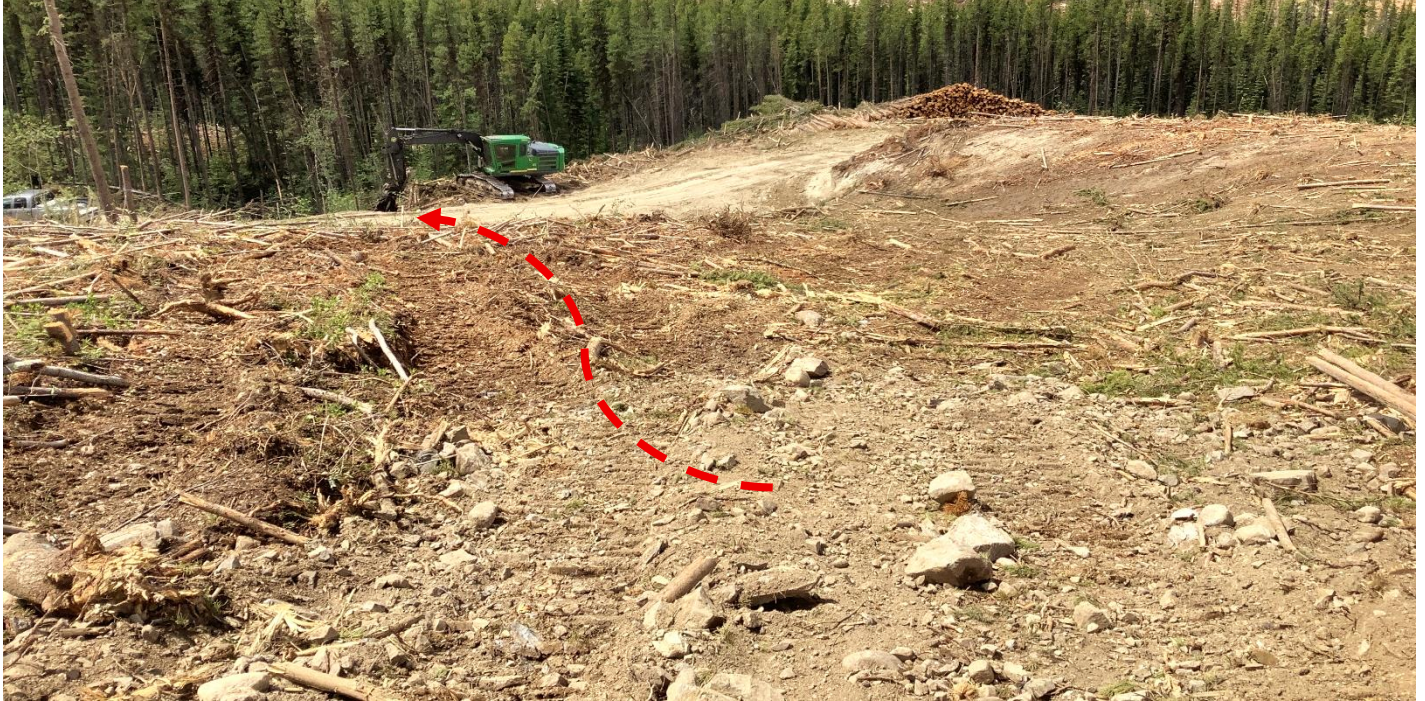
**Details:** A Tigercat 620D Skidder was backing up a skid trail when the engine stalled causing the skidder to start rolling forward. The emergency brakes failed to stop the skidder, and it rolled on its wheels for approximately 100m downslope, across a road and into standing timber. The skidder came to rest after knocking over about 10 trees along the cutblock boundary.

**SKIDDER PATH** (started in foreground of picture and rolled on its wheels for approximately 100 metres into standing timber below the roadside where loader is pictured):
