# MANUFACTURING SAFETY ALERT

### **Near Miss - Falling Material (SIFp)**

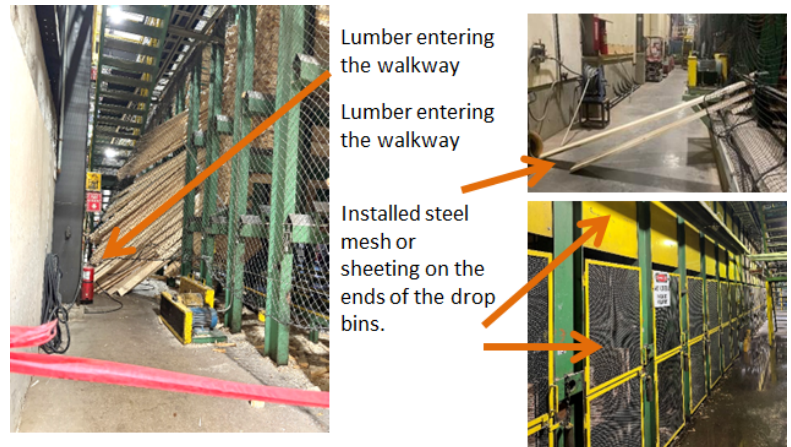
A cable on the sawmill drop bin broke, causing the right (east) side of the cradle to collapse and spill an almost full lift of two-by-six 16' lumber onto the ground-level walkway.

Although netting was in place to prevent lumber from spilling, it failed to stop the material from falling into the walkway.

Typically, a netting system had been sufficient to contain any misaligned lumber, but in this case, it did not perform as expected.

- Conduct a High-Risk Hazard Assessment (HRHA) for the removal of askew lumber.
- Restrict access to ground-level areas near sawmill and planer drop bins while sorters are operating.
- Perform a full incident investigation to identify root causes and contributing factors.
- Review with your crews and explore improved guarding solutions.

**Inspect drop bins to ensure guarding is adequate to contain lumber if an upset condition occurs like an unexpected event or equipment malfunction.**
