MANUFACTURING SAFETY ALERT

Cut Conduit

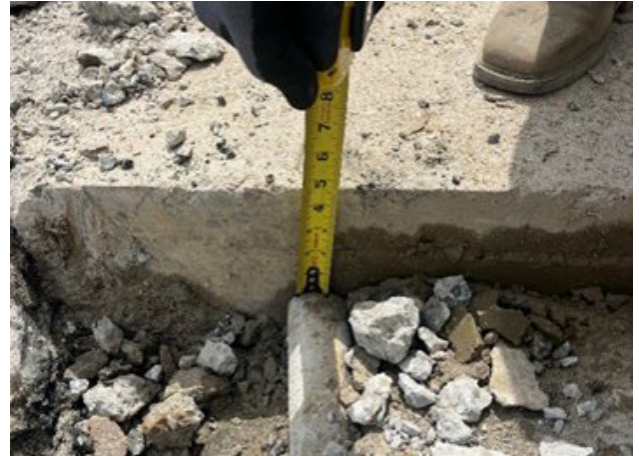
An underground electrical conduit was accidentally severed during concrete cutting. The damage went unnoticed until the mill restarted the following Monday, when the breaker connected to the line was repeatedly tripped. Work in the area was stopped to investigate. An excavation confirmed the conduit had been cut at the location where the concrete work had taken place.

A site scan indicated the conduit was about 2ft deep (though these readings can be distorted). The project manager had planned to mark the line but did not complete the task. In addition, the team leader performing the work was not familiar with the site’s specific cutting and digging procedures and went ahead with the concrete cutting, which resulted in the severed conduit.

- Work should never begin without obtaining and understanding the proper safe work procedure (SWP). According to the contractor’s SWP, all electrical lines must be located, painted and properly barricaded until the correct procedure is identified and put in place.
- When disturbing concrete, treat all underground utility lines as if they are 0-2ft deep, regardless of GPR readings. GPR scans can be distorted by a range of environmental factors and may not show exact depths.

Ensure all safe work procedures and site-specific requirements are clearly communicated to ALL contractors and subcontractors before ANY work begins.

Also ensure there is adequate company supervision of contractor activities to confirm they are following established procedures such as Job Hazard Analysis.
