# MANUFACTURING SAFETY ALERT

### **Mechanical Failure - Planer**

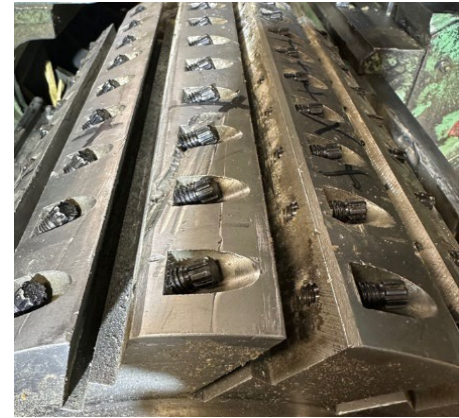
During post-holiday start-up testing, the planer's bottom head ejected its knives, causing a catastrophic failure that damaged the stator and knocked out power to the facility.

The failure occurred because the bottom knives changed during maintenance had not been torqued.

- Discuss the risks of complacency and distractions during repetitive or routine tasks with crews.
- Add torque wrench calibration and verification procedures to the monthly preventive maintenance schedule.
- Consider installing vibration sensors on all high-speed rotating equipment.
- Implement verification steps, such as a two-person check, for high-risk or sensitive machine set-ups.
