# MANUFACTURING SAFETY ALERT

### Process Safety SIF

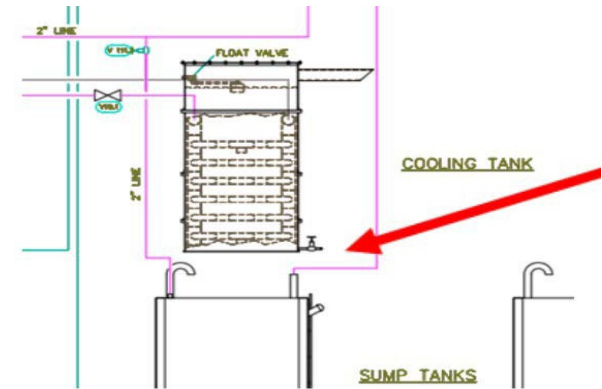
Electricians inspected the pressure transducer and confirmed it was functioning correctly. Further investigation found that the expansion tank was slightly pressurized, which should not occur since the expansion tank is vented to atmosphere.

Continued investigation determined that the vent line, which was exposed to the -28°C temperatures, had frozen. The blockage was located on a horizontal section of the vent line before it dropped down to the storage tank.

- Thaw the horizontal section of piping with tiger torch.
- Investigate applying heat tape and insulation to horizontal section of piping.
- Minimize water entering the thermal oil system by regularly checking and draining the low point drain on the storage tank.
