# MANUFACTURING SAFETY ALERT

### **Process Safety SIF**

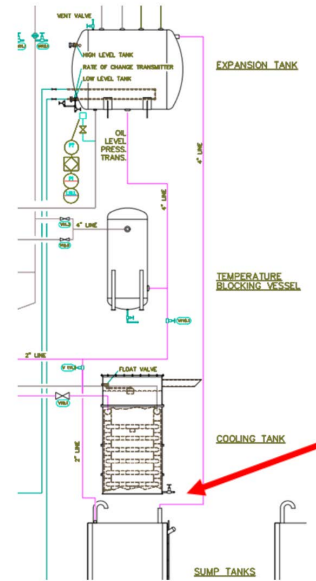
Continued investigation determined that the vent line, which was exposed to the -28°C temperatures, had frozen. The blockage was located on a horizontal section of the vent line before it dropped down to the storage tank.

- Thaw the horizontal section of piping with tiger torch.
- Investigate applying heat tape and insulation to horizontal section of piping.
- Minimize water entering the thermal oil system by regularly checking and draining the low point drain on the storage tank.
