# MANUFACTURING SAFETY ALERT

### 50% Caustic Spray

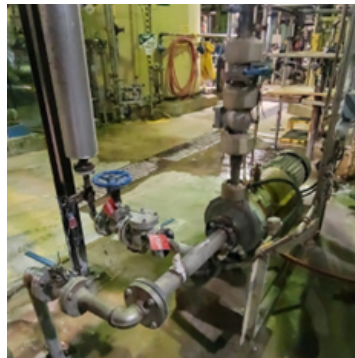
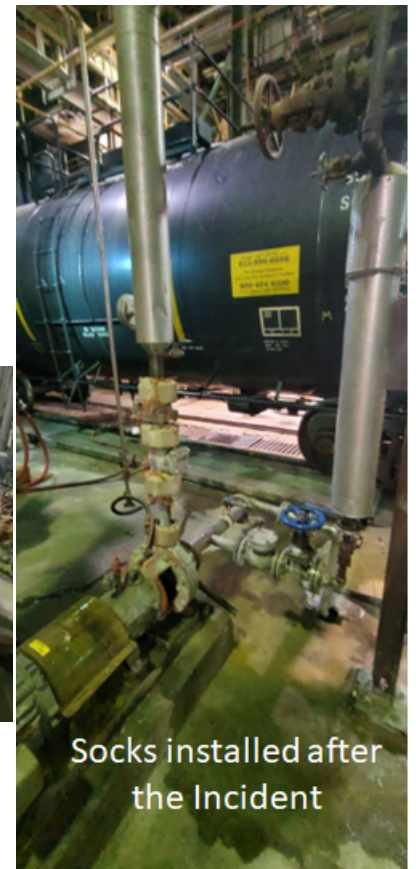
Shortly after starting the pump, Worker #1 heard a pop and a spray of 50% caustic hit the worker's face. The gasket on discharge valve of pump failed and was producing a spray of caustic that resembled a fire protection sprinkler head.

- Lockout out pump and replace the failed gasket.
- Install chemical resistant socks on discharge flanges.

Install chemical resistant socks on discharge flanges.
