FOREST INDUSTRY SAFETY ALERT

Log trailer bolster bolts: Inspect regularly for this hidden hazard

Location: All areas of B.C.

Date of Incident of Note: October 18, 2011

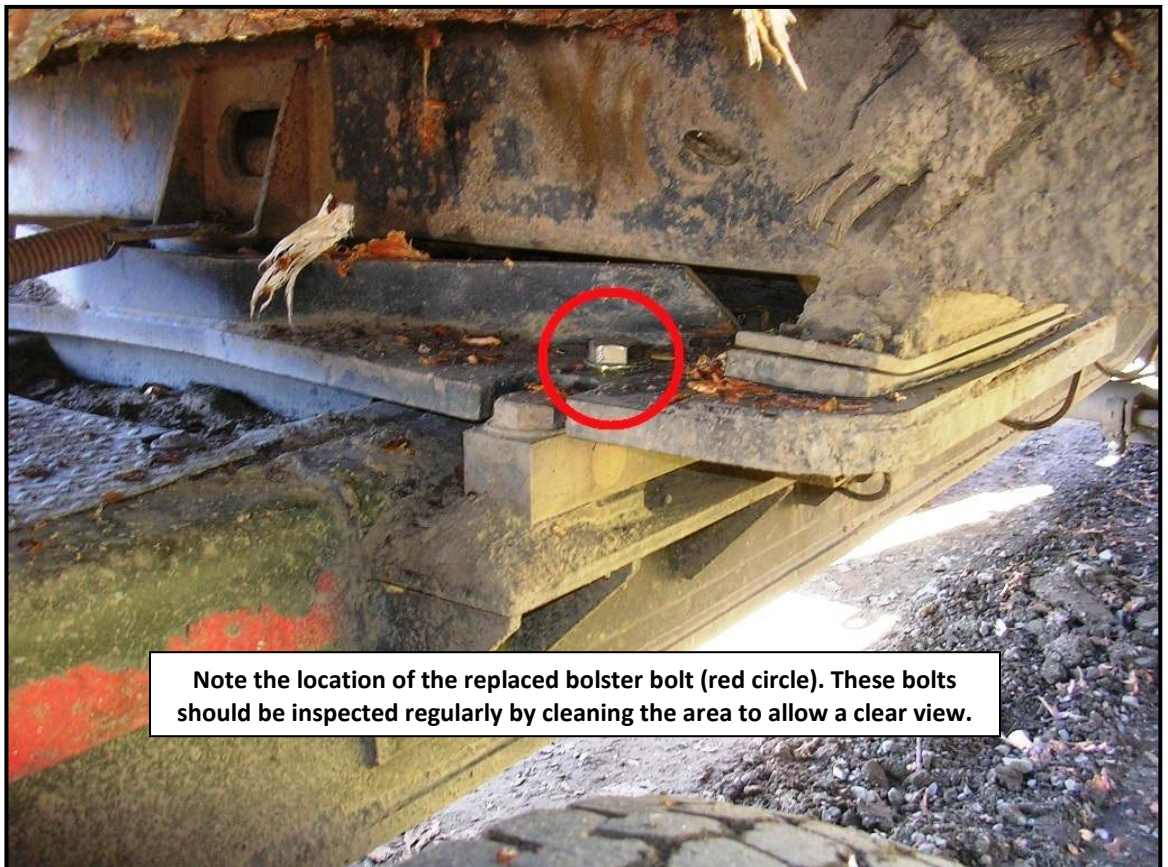
Details of Incident: A log truck driver noticed a broken bolster bolt while setting up for loading. He reported the problem to the site supervisor. Inspection of the bolt showed it had been partially broken for awhile. They noted that there had been a recent increase in the number of broken bolster and scale pad bolts.

These bolts form the link between the load and the truck and are subject to damage especially from excessive sideways force and rough handling during unloading. Excessive rocking caused by poorly built roads can also contribute to the damage.

Partially broken bolts are hard to notice due to their location and because of mud, snow or other material that can hide the part from easy viewing.

Note the location of the replaced bolster bolt (red circle). These bolts should be inspected regularly by cleaning the area to allow a clear view.

- Wheel loader operators must be aware of the need to avoid excessive sideways strain on loads and/or rough handling during unloading.
- Contractors should consider changing these bolts annually (for example, during breakup or other curtailed operations)
