Safety Alert of THE MONTH

January 2019

Metal Objects (and rocks) Left in Logs Create a Hazard to Equipment and Workers

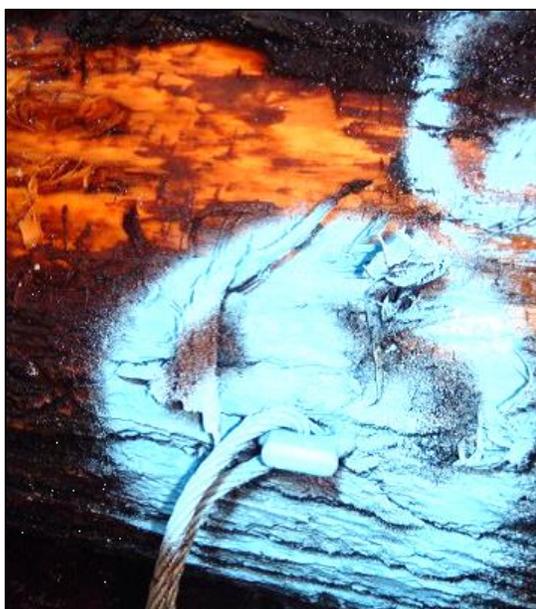
If the decision is made to load out the logs from an old bridge or wooden culvert, all the hardware must be removed prior to loading AND any holes should be bucked off the log. These holes can hold rocks and debris.

To ensure all foreign material is removed, the logs will need to be rotated and closely viewed by a ground worker.

If uncertain if a log has embedded metal, either use a metal detector to confirm or do not load the log.

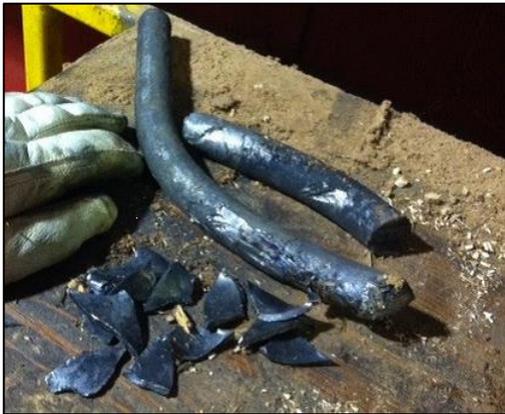
Above Left: Metal found in saw log and broken teeth.

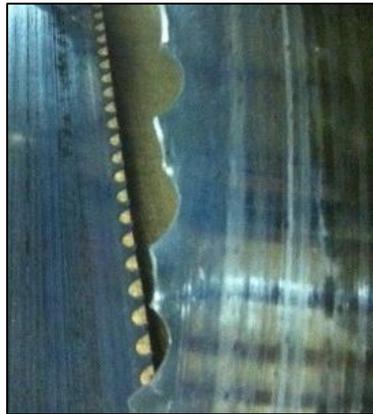
Middle: Band saw with sheared teeth following impact.
