SAFETY ALERT

Date: August 1, 2015

Cable Come-Along Break

Location: Castlegar, BC

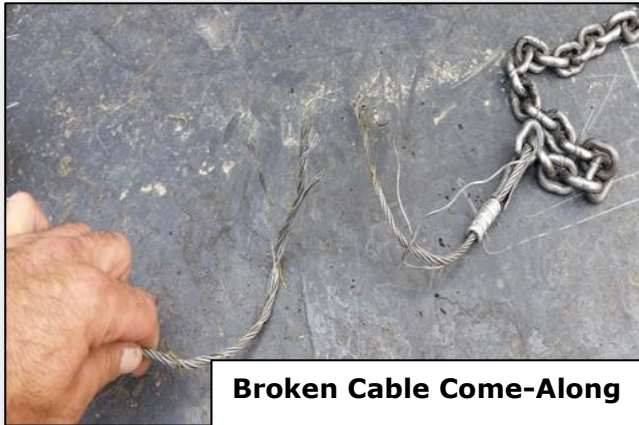
Broken Cable Come-Along

Summary: A ¼ inch cable come-along was used to assist with hoisting. The cable was inadvertently caught, stretched and broke while under tension, which caused it to fly up and strike a worker in the face. Medical aid was sought, and worker was later released to the worksite.

Hazard: Cable come-alongs can be compromised and break especially if pinched or if poorly maintained. A cable break can have huge “struck-by” consequences to the workers involved.

- Avoid using cable come-alongs; opt for the more reliable chain-type.
- Anticipate worst-case scenario and ensure workers are in-the-clear.
- Ensure workers are trained and feel proficient with come-along use.
- Come-along equipment must be stored properly and inspected prior to use.
- Enforce consistent use of PPE, which may require eye or face protection.
- Always ensure the object does not weigh more than the come-along’s capacity.

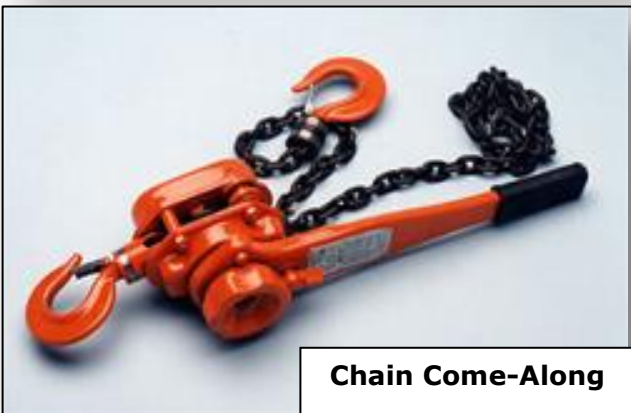
Chain Come-Along
