# SAFETY ALERT

## DESCRIPTION OF EVENT: Concussion From Being Struck With a Pike Pole

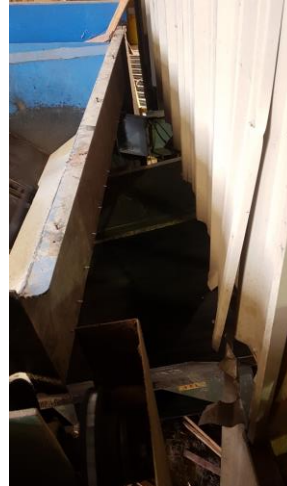
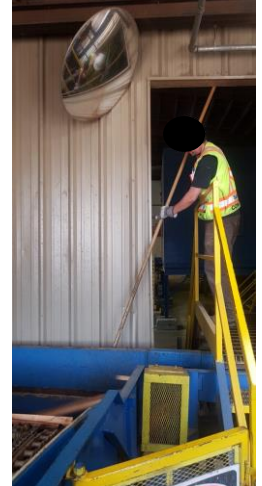
A worker was using a pike pole to straighten a cross-up at the strip machine unscrambler pocket. The waste belt under the unscrambler was left running, which had been a regular practice.

When the tip of the pike pole caught on the waste belt below the unscrambler, it caused the back end of the pike pole to strike the worker on the right side of head, just behind the ear, causing the worker's hard hat and safety glasses to be knocked off.

There is usually a UHMW deflector in place, but it had become loose and removed for repair. The amount of crossed up sticks in the unscrambler pocket had increased and the operator had performed the same motion of unjamming sticks a few times that morning.

When there are recurring upset conditions get help or get the issue fixed so that you eliminate your exposure to the hazards.

- Always keep body out of the line of fire.
- The clearing cross-ups JSA has been reviewed and updated to include stopping belts under equipment being worked on with a pike pole.
- Review incident and pike pole safe work procedures with all crews.
