## DESCRIPTION OF EVENT

### PIECE OF STEEL FELL FROM ABOVE

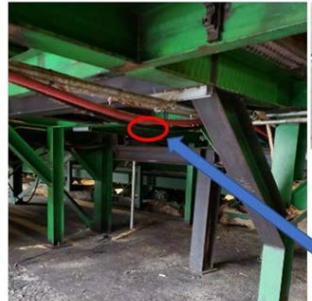
A clean-up employee was shoveling debris underneath the MGR into a vibrating conveyor when a piece of steel (chain capture) 15'x8'x3/8 weighing approximately 10 lbs fell to the ground and landed about 2' in front of them.

The piece of steel was believed to be left behind from previous maintenance work. It is uncertain how long the piece of steel could have been there before it fell.

Probable location of the piece of steel before the incident. Distance from top of cross member to the ground is just over 4'.

- Review the incident with maintenance teams to ensure they understand that housekeeping standards must be upheld, and all items must be put away after maintenance work is completed.
- Inspect the site to ensure no parts or other items have been left in an unsafe and elevated position.
- Review the incident with all employees to discuss the importance of inspecting elevated areas for hazards when starting or finishing a job/task. It may not be possible to see all items during the pre-work hazard assessment and lockout process.
