SAFETY ALERT

DESCRIPTION OF EVENT: Concussion From Striking Face on Steel Cable

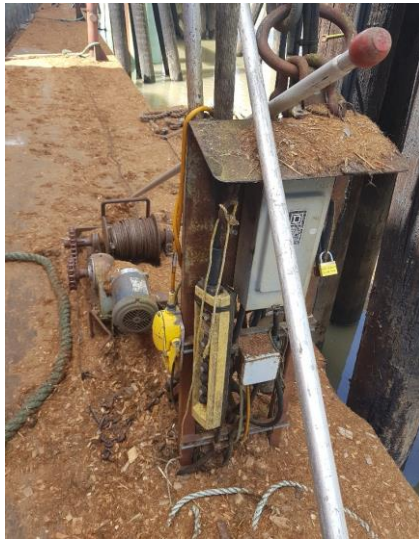
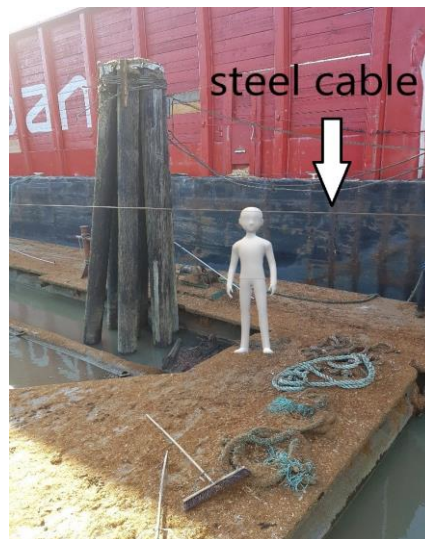
A new worker was adjusting the position of a chip scow using the manual controller located on the float. The worker unintentionally caused the scow to drift out causing one of the steel cables to lower to face height.

The worker noticed the scow drifting out and wanted to save the chips from falling into the water by running to the Crow's Nest to adjust the spout position. The worker ran into the low hanging steel cable, was knocked to the ground and suffered a concussion.

Consider moving the cables to eliminate crossing over work areas.

- Review the current cable locations to determine if they can be moved to eliminate crossing over work areas.
- Ensure all new workers have adequate training, feel comfortable conducting tasks that have been assigned to them and are assessed for competency.
- When dealing with upset conditions, take the required time to assess the situation.
- Never run on site.
