DESCRIPTION OF EVENT

Lockout Verified | *Lockout Violation*

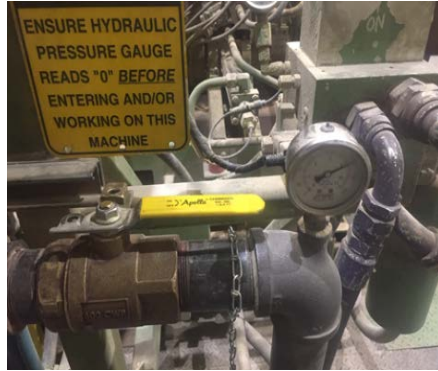
Two lockouts were conducted by two separate workers. A millwright locked out the main air for the Log Processing In-feed using a scissor clamp and a maintenance person also locked out the main air for the Log Processing In-feed. Both lockouts were verified and documented by a supervisor.

The main air was locked out with the valve in the **OPEN position** so the energy was **not isolated** (see image example).

- Review the current lockout verification process to determine if adequate verifier competency assessments are being performed. Develop a lockout verifier assessment if no system is present.
- The employees and supervisors that participated in the lockout violation should undergo re-training on the lockout process.
- This incident is being shared with industry to remind others to review lockout processes.
