DESCRIPTION OF EVENT**Lockout Verified Lockout Violation**

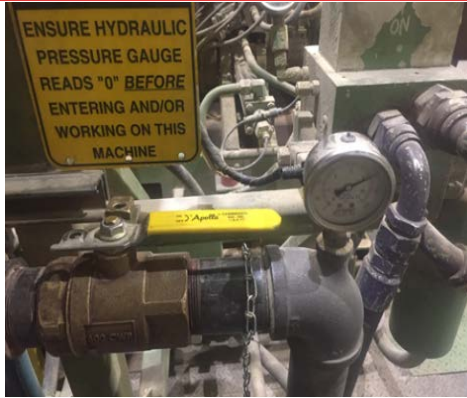
A Millwright locked out the Main Air for the Log Processing Infeed (using a scissor clamp). A clean up person also locked out the Main Air for the Log Processing Infeed. Both lockouts were verified and documented by a Supervisor.

The Main Air was locked out with the valve in the **OPEN position** therefore the energy was **not isolated** (see example picture).

- Review the current lockout verification process to determine if adequate verifier competency assessments are being performed. Develop a lockout verifier company assessment if no system is present.
- The employees and supervisors that participated in the lockout violation will undergo re-training on the Lock Out process.
- This incident is being shared with all employees as well as other companies in an effort to provide the industry with ongoing support.

Verify the competency of lockout verifiers on an ongoing basis.
