MANUFACTURING SAFETY ALERT

Lockout Violation – Crossing Guardrails

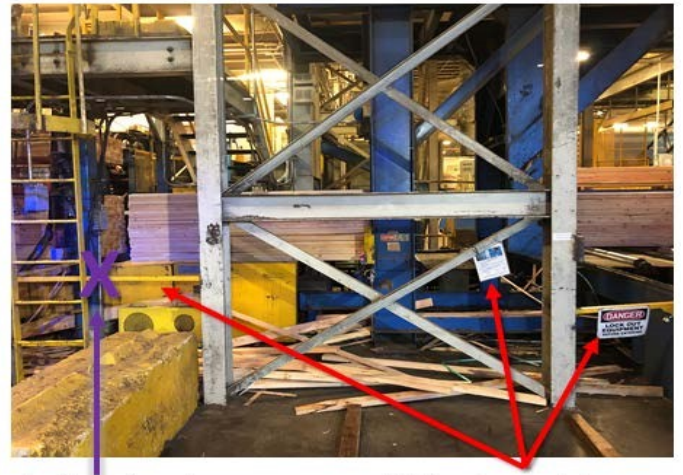
While attempting to troubleshoot an issue with Planer Stacker Hoist, a Shift Millwright stepped through a guardrail and into a lockout area in order to clear lathe and chunks around the out-feed rollcase.

Position of employee
(behind ladder)

LO Boundary and signage

- Use this incident to stress the importance of understanding lockout boundaries. Whenever in doubt, stop and ask your supervisor.
- Ensure that all lockout areas have clear boundaries.
- Perform Field Level Risk Assessments (FLRA) to help with pre-task safety planning.

By-passing lockout or entering into lockout high risk areas without lockout puts you at risk for a serious injury.
