MANUFACTURING SAFETY ALERT

Bandsaw Damaged Saw Removal

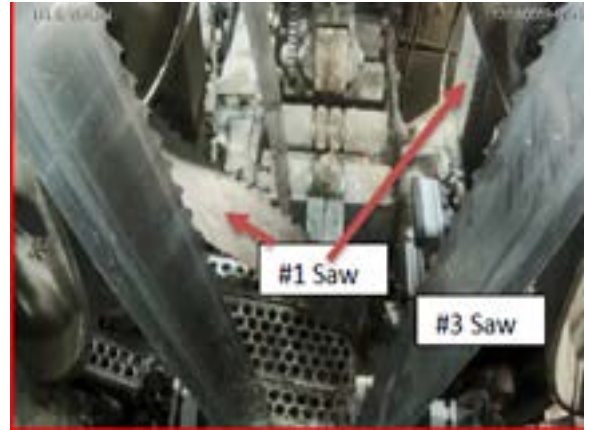
An employee grabbed hold of a twisted saw. He pulled it with two hands, however it was caught on a guard above him.

He used his right hand to unhook the saw from the guard and when it released, the bottom part of the twist then banged the back of his left hand against opposing saw's teeth.

Employee received stitches to forearm.

The foreground right saw is a new saw #3, and the saw being removed as #1 (saws to the left are #2 & #4) Filer was also located below the platform to the left.

- Investigate why cants are getting stuck in the bandmill.
- Perform risk assessments prior to removing damaged saws.
- Change procedure to remove damaged saws prior to new saws being installed.
- Ensure appropriate PPE is worn including cut resistant air sleeves.

Performing pre-work assessments prior to working in an upset condition can help to identify and mitigate significant risks.
