MANUFACTURING SAFETY ALERT

Self-Tapping Screws/Cable Tray

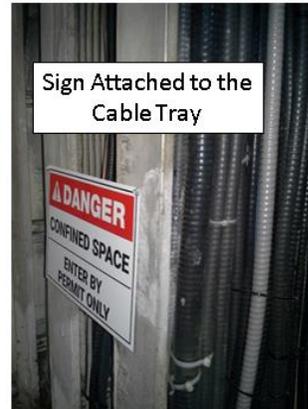
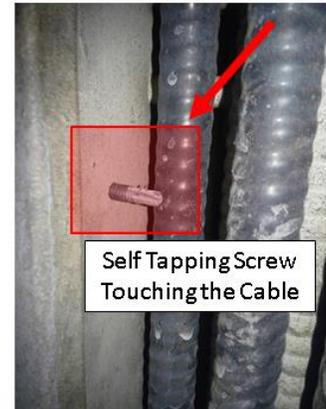
A sign in a MCC room had been attached to a cable tray using self tapping screws. This cable tray houses 600 VAC power cables, the self tapping screw end went through the cable tray and appears to be very close to one of the cables. Cable trays throughout the mill can house anywhere from 120 VAC to 13,800 VAC.

- Removed signs attached to cable trays, electrical equipment or other equipment if the sign placement was not approved by the electrical or maintenance department
- Communicate the hazard to all maintenance personnel
- Perform an audit of the operation to identify any signage that is incorrectly placed in a hazardous spot. When performing the audit include personnel from various departments (millwrights, electrical, JOHSC).
- Consider adding this item to the monthly JOHSC inspections.

Signage should not be installed on cable trays or any electrical or otherwise hazardous structure.
