MANUFACTURING SAFETY ALERT

Serious Near Miss-Piece of Edger Saw Ejected

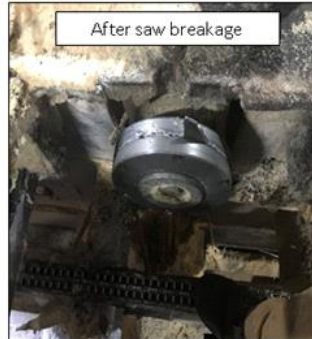
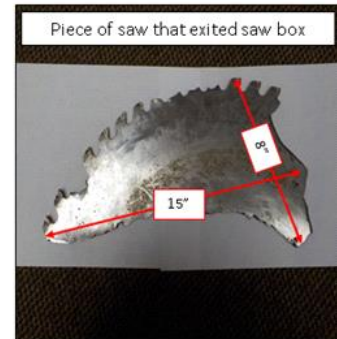
A slab was caught between the guard and saw of the saw edger. While the edger shifted the saws to the next set; the saw was pushed against the slab causing the saw to break apart. The piece of saw exited the saw box through a gap in the guard, traveled through the wall of the sawmill landing onto the infeed chains of the sharp chain. There were no injuries.

- Inspect all saw box enclosures to ensure that there are no gaps in the guarding and projectiles, or broken saws cannot leave the saw box.
- Perform a risk assessment on personnel access to hazardous areas (saw boxes, equipment outfeeds or potential projectile zones). Also consider basement areas.

Limit personnel access to hazardous projectile zones. This includes the risk of broken saws from equipment.
