MANUFACTURING SAFETY ALERT

Serious Incident – ATV Incident

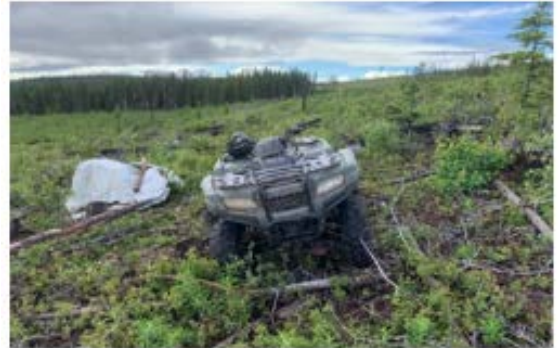
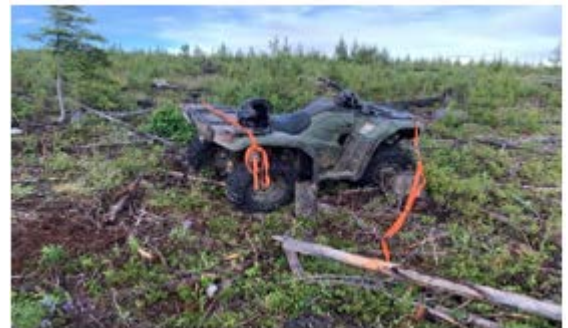
In June 2020, a contract planting supervisor was operating an ATV loaded with boxes of seedlings (3 on front, 3 on back). The supervisor made the decision to drive across the open harvested area, as the block road was inaccessible.

While travelling through the cut block, the front tire of the ATV tipped on its side, pinning the operator between the ATV and a stump.

The worker was treated by the First aid attendant and sent to the hospital where an x-ray identified 3 fractured vertebrae.

1. Whenever operating vehicles, mobile equipment or ATV's full attention ***must*** be on the route and obstacles.
2. If ATV's are to be used to carry items, load in a balanced way, and ensure 4 points of contact of the load straps to reduce load shift. A maximum load limit should be set.
3. Avoid traveling on side slopes.
4. When operating ATV's in areas with large amounts of debris and obstacles, ensure you have a clear path before proceeding.
5. Keep all handheld radios dry and carry a whistle to call for help
6. Consider walking and marking a quad route in difficult terrain prior to ATV use.

Consider 'walking the route' and marking a safe path when operating an ATV in difficult terrain.
