MANUFACTURING SAFETY ALERT

Property Damage – Cut Off Saw Failure

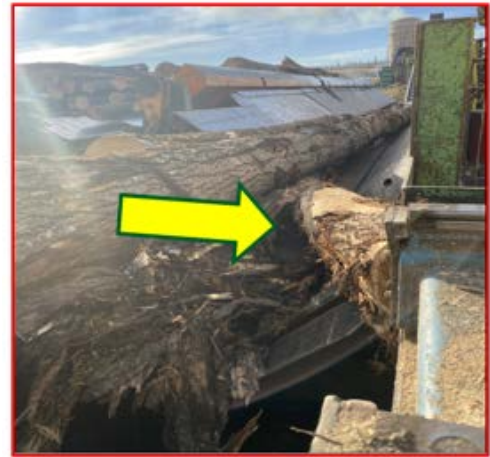
A crooked log entering the Cut Off Saw was stopped to cut off the overhung end. The crooked log was trapped under two other logs on the cut-off saw infeed conveyor. Once cut, the crooked log fell sideways into the running Cut-Off saw blade, causing the blade to break apart. There were no injuries and the 72” circular saw blade pieces were contained within the guard.

Crooked log trapped under two others

1. If possible, reverse the infeed chains to eliminate problematic logs.
2. Call for help to lift logs out of Cut Off Saw infeed.
3. Coach Cut Off Saw workers to stop, assess the risk and develop safe plans to address upset conditions.

Stop and assess upset conditions using your site FLHA process. Determine the safest way to clear jam-ups rather than forcing them through the process.

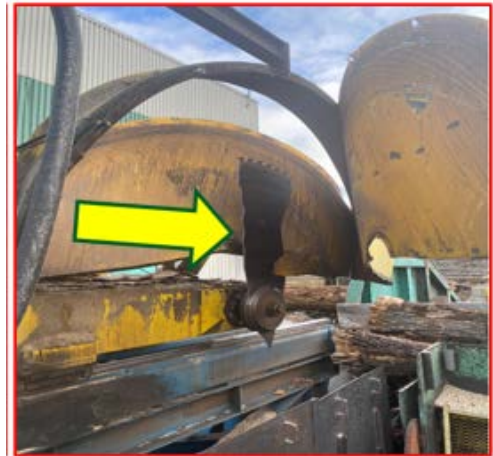
Cut-Off saw blade after breakage
