MANUFACTURING SAFETY ALERT

Serious Near Miss

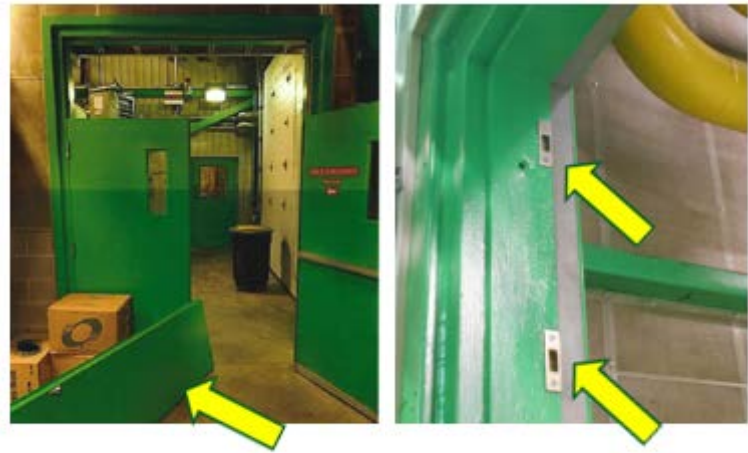
In August 2020, a worker entered an electrical room through the door. Just after they entered the overhead removable panel fell to the floor narrowly missing the worker. The overhead removable panel weighs approximately 25 kgs. There were no injuries.

Removable panel after it fell

1. Inspect all areas of the sawmill to identify overhead hazards.
2. Ensure that all overhead hazards are controlled with engineering controls.
3. For high-risk overhead hazards consider including these in the monthly JOHSC facilities inspection.

Verify overhead re-movable panels are fully latched and in place. Consider including these on the monthly JOHSC monthly inspection.

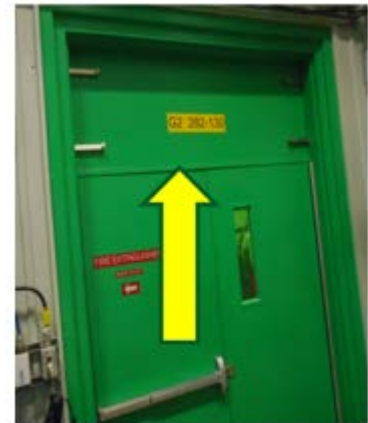
Removable panel latches.

Removable panel in place
