MANUFACTURING SAFETY ALERT

Forklift Spray Paint Can

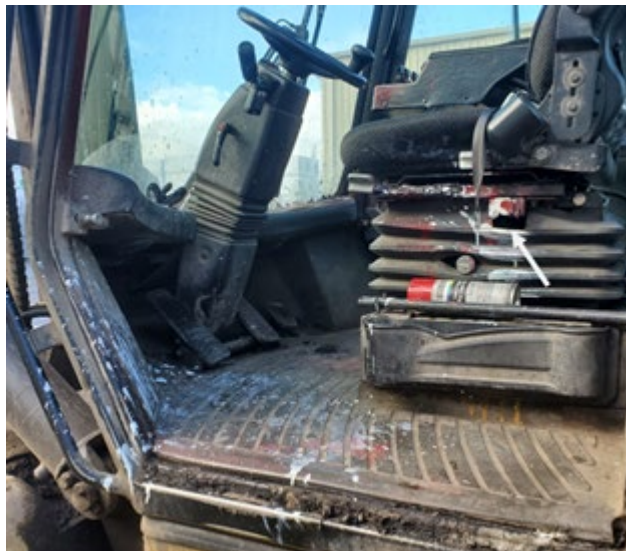
A forklift was driving through the rough yard and went over a bump. A spray paint can was stored on the air ride seat. The air ride seat bounced when going over bump and punctured the incorrectly stored spray paint can. Paint sprayed on floor of cab and on operator's pant legs.

- Pre-trip inspection form should specifically include loose objects in cab.
- Supervisors must audit periodically to ensure compliance.

Avoid carrying loose items and correctly secure all items in your forklift cab.
