MANUFACTURING SAFETY ALERT

Hoist Malfunction

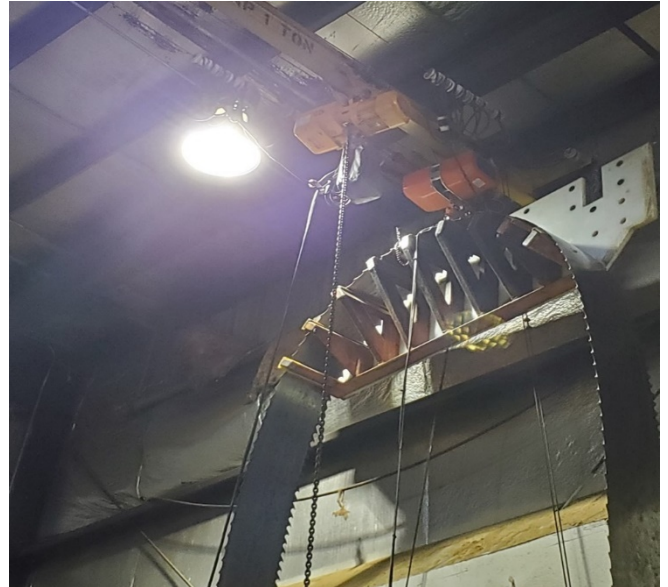
Two employees were performing a saw change for the Headrig bandsaw using a hoist in the filing room. The hoist was lifted, and Employee #1 began pulling the saw cradle towards themselves. Employee #1 then heard a loud noise, stopped operating the hoist and took a step backwards out of precaution. The excess hoist chain fell out of the chain basket and landed on the floor near Employee #1. The incident was immediately reported, and the hoist was removed from service.

- Ensure hoists are inspected before each use and report any deficiencies to supervisor immediately.
- Reminder to never stand directly under suspended loads. Stand to the side away from any possible hazards.
- Be aware of surroundings and make sure a clear exit path is available should a failure occur.

Always conduct a pre-use inspection of hoists and cranes prior to use and if any deficiencies are found tag out of service and report immediately to your supervisor.
