MANUFACTURING SAFETY ALERT

DESCRIPTION OF EVENT

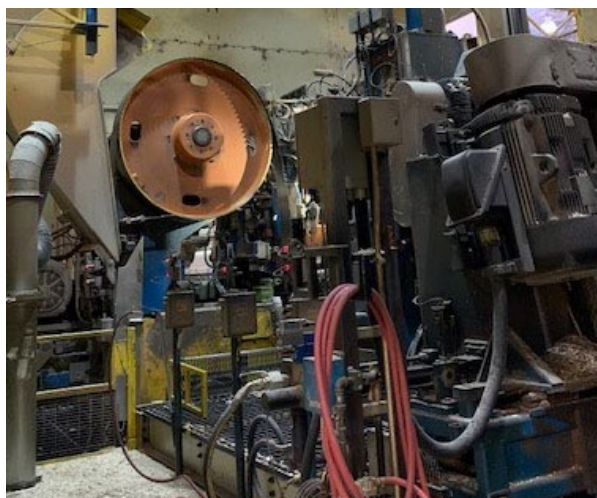
During a scheduled bandsaw change on the 8” canter an employee proceeded to remove the saw from the wheel prior to the saw cradle being lowered into position.

The saw came off the wheel and fell into the conveyor below narrowly missing the employee. The employee was uninjured in this incident, but had circumstances been different, could have been struck and/or cut by the saw. The saw change procedure requires that the saw cradle be in position prior to personnel entering the saw area.

1. Install beacons to alert personnel when safe or un-safe to enter area.
2. Install gate or barrier as a stop gap so that employees are forced to look to ensure area is safe before entry.
3. Ensure workers follow company lockout procedure.
4. Have supervisor conduct frequent observation/assessments on workers regarding lockout and following safe work procedures.

Ensure workers follow all saw change safe work procedures and lockout when changing saws.
