# MANUFACTURING SAFETY ALERT

## DESCRIPTION OF EVENT

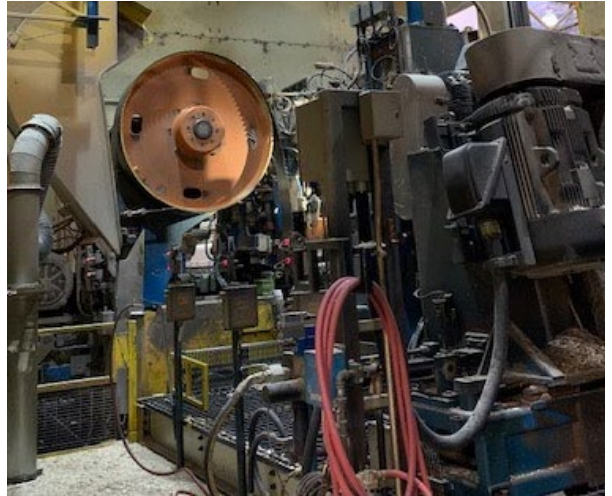
During a scheduled bandsaw change on the 8” canter an employee proceeded to remove the saw from the wheel prior to the saw cradle being lowered into position.

The saw came off and fell into the conveyor below narrowly missing the worker. The worker wasn't injured but could have easily been struck and/or cut by the saw.

The saw change procedure requires the saw cradle be in position prior to employees entering the saw area.

1. Install beacons to alert employees when an area is safe or un-safe to enter.
2. Install gate or barrier as a stop gap so that employees are forced and look to ensure area is safe to enter.
3. Ensure employees follow the company lockout procedure.
4. Have a supervisor conduct frequent inspections with workers regarding lockout and safe work procedures.

Ensure workers follow all saw change safe work procedures and lockout when changing saws.
