MANUFACTURING SAFETY ALERT

DESCRIPTION OF EVENT

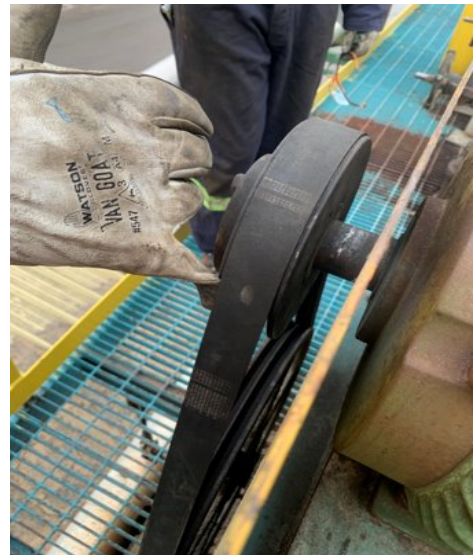
While re-seating a drive belt back onto a kiln fan shaft drive sheave, a millwright’s gloved pinky finger became caught between the belt and sheave. The belt was lodged between the fan shaft sheave and the belt guard backing plate.

The Millwright was pulling with his right hand on the wedged belt, while counter-rotating the sheave with his right foot and an Oiler was assisting. When the belt freed, the stored energy quickly accelerated the belt, pinching the Millwright’s finger.

1. Always release tension mechanically when removing belts from sheaves. Do not roll belts on to sheaves.
2. Continually assess hand and finger placement to ensure they are not placed in the bite during the task.

When performing work on drive units always consider ‘stored energy’ as part of the pre-job hazard assessment.
