SAFETY SHARE

Log Intrusion – John Deere Forestry Forwarder

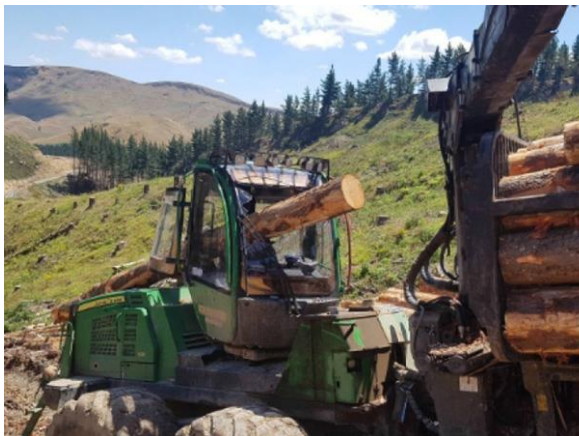
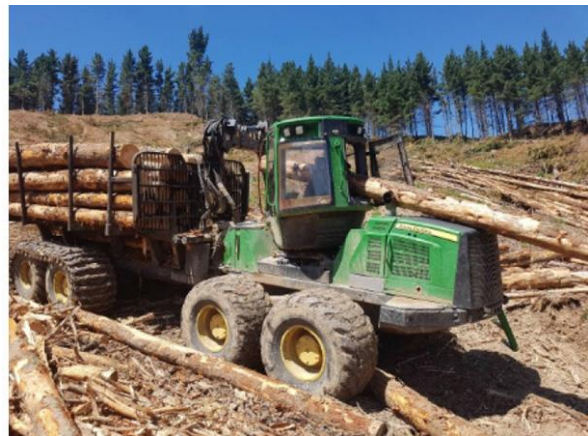
In April 2018, a 20-30cm/6m, 400kg log broke through the 12 mm polycarbonate front and rear screens of a forwarder operated by a customer of CablePrice in the lower North Island.

In April 2018 a 20-30cm, 6m, 400kg log smashed through the 12mm polycarbonate front and rear screens of a forwarder in the lower North Island.

While there were many contributing factors to this incident, the safety of the machines we supply and the health and safety of our people and our customers is the number one priority at CablePrice. The polycarbonate met the current requirements for Operator Protective Structures (OPS) from WorkSafe NZ and meet the ISO 12117 and ISO 8084 which are the International Organisation of Standards requirements for Forestry Machinery.

- Ensure you are using the right machinery for the job. This includes providing suppliers and certifiers with an accurate understanding of the task and situation you will be putting the machinery to use in.
- Ensure that all manufacturer's instructions and recommendations are being followed.
- Ensure staff are trained and have a good understanding of the risks and safe operating of the machinery they are using.
- Do not load bunk higher than the cab protection barrier (headboard).
- Install additional cab protection. CablePrice can assist with the supply and install of this protection.
