**THIS UPDATE REPLACES SAFETY ALERT #12 (13/10/21)**

Safety Alert #: 012A

Subject: **Stem Entered Harvester Cabin**Date: 6<sup>th</sup> October 2021

Location: Kaingaroa Forest

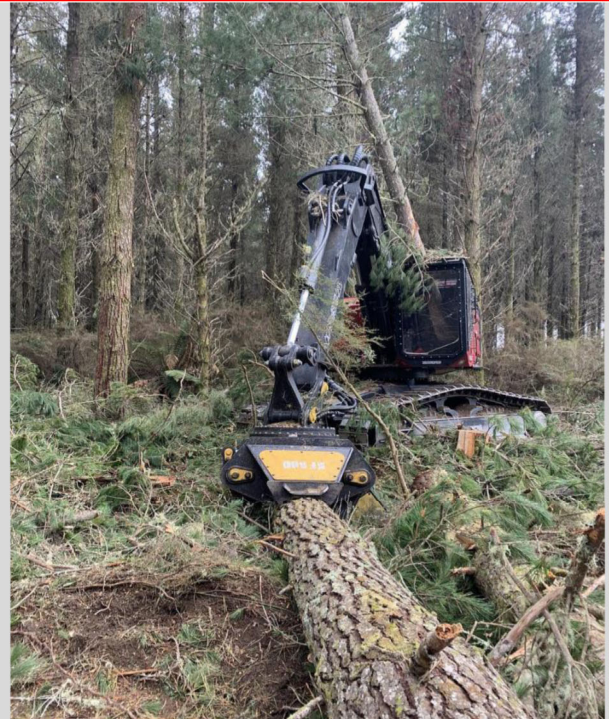
One leader has come down landing close the machine. The second, larger leader, has fallen vertically down into the machine entering the cabin area via the emergency escape hatch, piercing the operators seat. The leader was approximately 740 kg with a sharp tip.

The operator escaped serious injury or death because he had noticed the double leaders had snapped off the main stem of the log. The snapping has prompted the operator to move forward and look up. It is believed the second leader has entered the cab at this point. When the leader entered the cabin, it scratched the operator's back causing relatively minor abrasions.

An investigation into the cause of the incident is ongoing and we are liaising with the machine's manufacturer. The ISO 8083:2006 standard, specific to forestry machines, requires the FOPS guarding to withstand a 227kg object falling from a height of 5.2 metres. The machine appears to have met this standard. However, in this incident a 740kg object fell from a height of 10 metres exerting forces which exceed the current standard.

- The manufacturer has made a strengthened emergency hatch. All Timberpro machines (with escape hatch) operating within the KT estate were stood down until strengthened emergency hatches were fitted.
- Timberlands' harvest managers, together with contractor principals, are reviewing roof escape hatches in other harvesting operational machines.
- A review of the ISO 8083:2006 standard may be required in due course.
