Safety Alert

Stem entering processor cab

30th May 2019

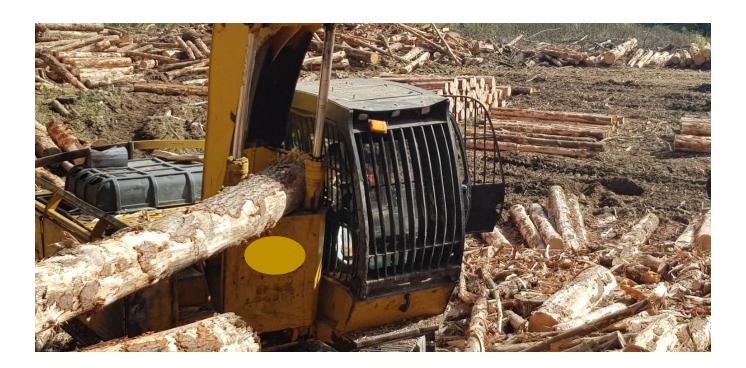
- The stem went in-between the lift rams, past the boom and had enough force to destroy the
 operator protective structure and partially entered the cab. It struck the operator on the right
 arm, thankfully the velocity was reduced, and the operator only suffered bruising.

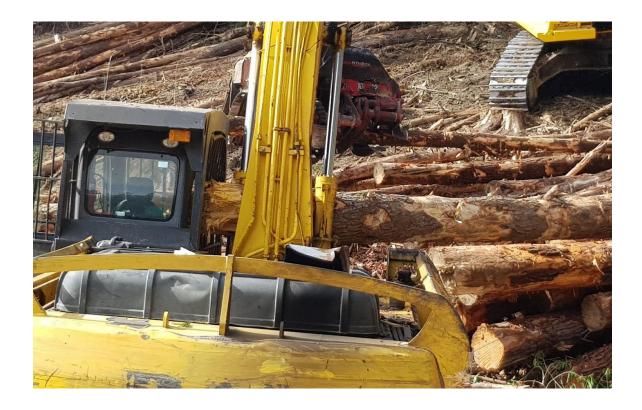
- The operator protective structure performed as it should have and saved the operator from significant harm.
- Although this machine has current and valid OPS, FOPS and ROPS protection, the escape hatch is unprotected and was exposed to the hazard every time the processor turned away from the stockpile to place wood in his cut-pile.

- Retrofit a guard on the escape hatch that can be opened from inside the cab and from outside the cab. All machines performing a task where there is a potential for a log the enter the escape hatch, should have adequate protection fitted.
- Avoid working under stockpiles.
- Always move machines to safe areas to perform maintenance.
- Don't presume that stems are stable, and they won't move.
- Install higher lift ram guards:
