MANUFACTURING SAFETY ALERT

DESCRIPTION OF EVENT

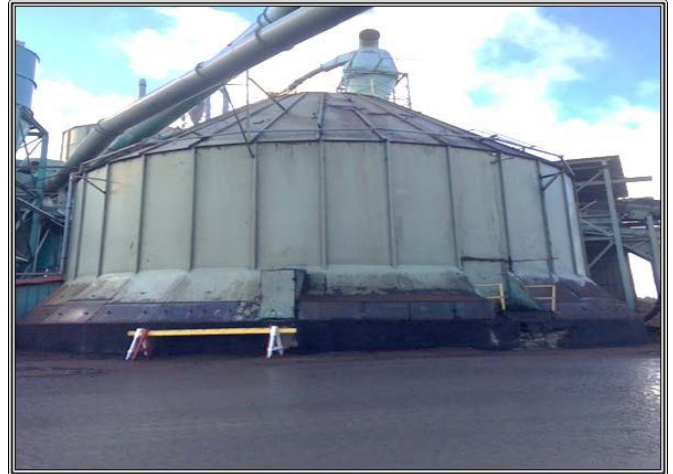
A worker was in the process of cleaning in the Auxiliary Shaving Bin when an adjacent pile sloughed, engulfing the worker.

The worker had one arm free and was attempting to free themselves when a co-worker arrived and helped free the worker.

- Assess worksites for similar potential engulfment / entrapment hazardous conditions.
- Conduct a hazard assessment and develop safe work procedures for all identified areas. If the engulfment hazard is located in a confined space, ensure that the hazard assessment is performed by a qualified person as defined in OHSR 9.11 (2).
- Take appropriate measures to control the risk of entrapment or engulfment and, if the risk is not eliminated, the worker uses a lifeline and harness of a type that will keep the worker in a position so as to be able to be rescued and is continuously tended by a standby person who is equipped for and capable of effecting immediate rescue.

Ensure no employee or contractor enters or remains in any place where there is a danger of entrapment or engulfment in loose materials or from other circumstances. If the engulfment hazard is located in a confined space, ensure that all applicable confined space safety procedures are followed.
