# MANUFACTURING SAFETY ALERT

### **Fall from Elevation**

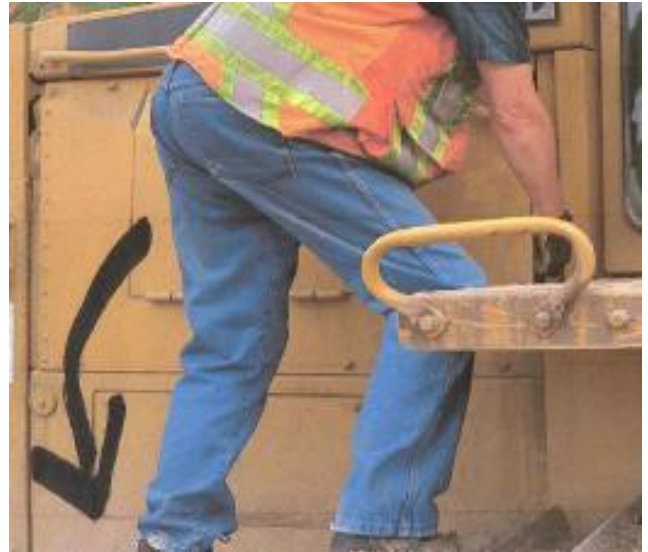
Due to an engine overheating alarm a worker exited the cab and stepped down onto the tracks to open the side engine access cover to check the turbine.

A malfunctioning ripper hydraulic control lever caused the hydraulic system to overheat. This defect was known by the worker but they did not report or document the issue on the pre-use inspection.

While holding the access cover with both hands, the worker had to back up to allow the cover to open. The access cover fell off its hinges, causing the worker to lose balance, and fall onto the tracks. The worker then slid down the slope of the tracks head first.

The incident resulted in the worker injuring his left arm, ribs and 2 lacerations to his right knee. The lacerations required a total of 8 stitches to close.

- Review equipment pre-use inspection system with workers, focusing on testing of equipment before use and immediately reporting defects.
- Inspect and possibly modify all engine access cover hinges so that the cover will not come off the hinges when opened.
- Install a smaller inspection door on the cover so that operators can conduct pre-trip inspections without having to open the larger cover.
- Remind operators to maintain 3-point contact when opening the engine access covers (use handrail).
